Key recommendations for the Barrier Highway

Key recommendations for Broken Hill

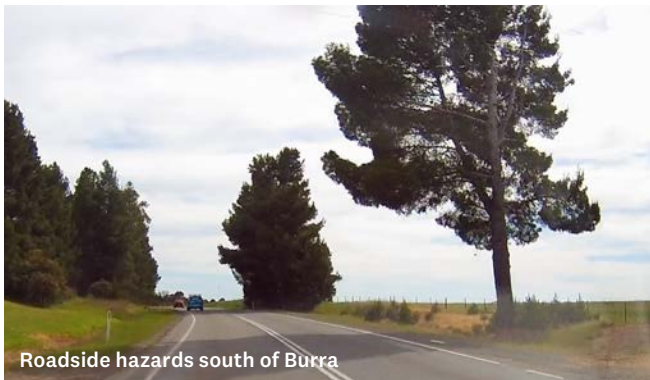
Roadside hazards south of Burra

Progressively install safety barriers along the highway, focusing on areas with curves and exposed roadside hazards in the hilly terrain between Oodla Wirra and Nackara. Reduce the frequency of exposed, hazardous vegetation south of Burra.

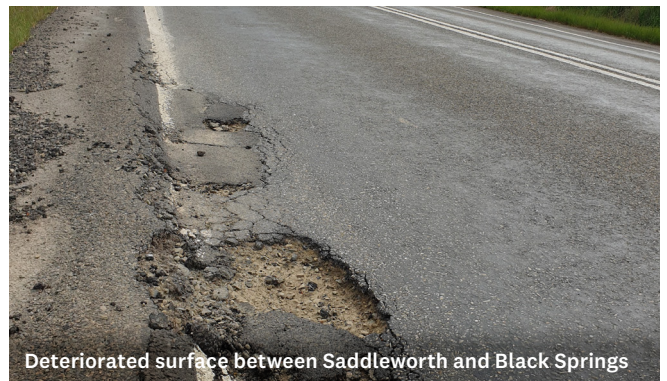
Deteriorated surface between Saddleworth and Black Springs

Complete road resealing, sealed shoulder widening and localised pavement reconstruction between Giles Corner and north of Burra, prioritising the section between Saddleworth and Black Springs. Localised pavement repairs, resealing and sealed shoulder widening are also required between Cockburn and Broken Hill.

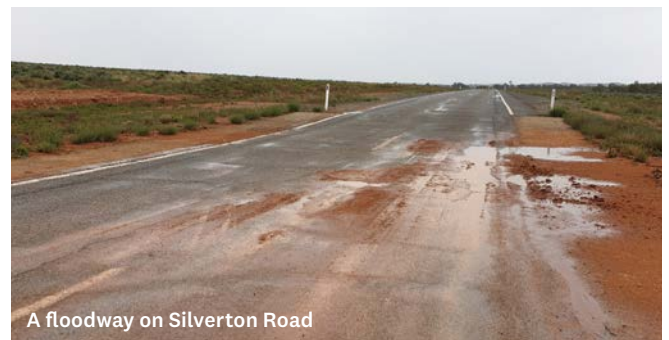
A floodway on Silverton Road

Reseal Silverton Road, considering localised pavement reconstruction and drainage improvements. In the short term, flood depth indicators and associated signage are required at all floodways along the road.
