# **Regional Road Assessment: Broken Hill and Barrier Highway**

Report – June 2023

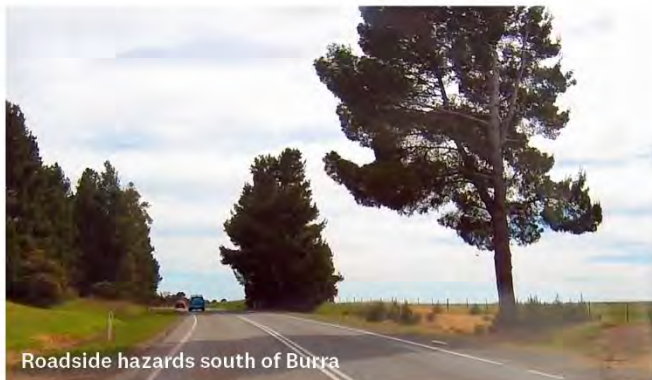
Roadside hazards south of Burra

Progressively install safety barriers along the highway, focusing on areas with curves and exposed roadside hazards in the hilly terrain between Oodla Wirra and Nackara. Reduce the frequency of exposed, hazardous vegetation south of Burra.

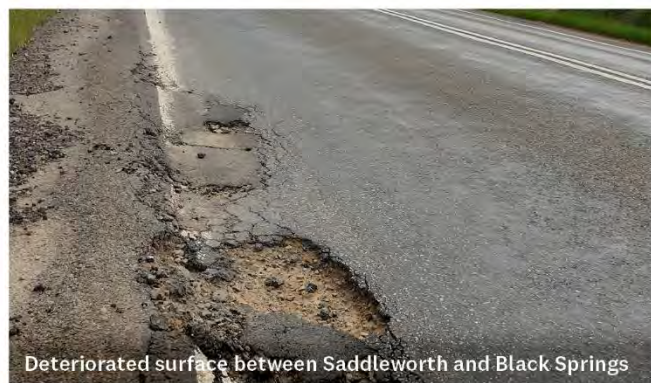
Deteriorated surface between Saddleworth and Black Springs

Complete road resealing, sealed shoulder widening and localised pavement reconstruction between Giles Corner and north of Burra, prioritising the section between Saddleworth and Black Springs. Localised pavement repairs, resealing and sealed shoulder widening are also required between Cockburn and Broken Hill.

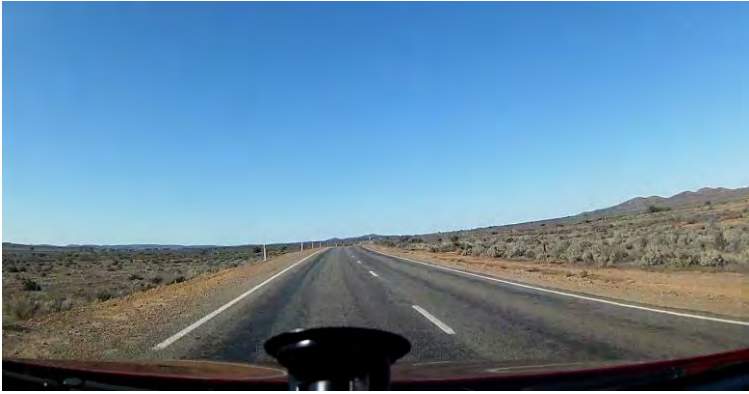
Site coordinates: -32.52290, 139.70015 (heading northeast)	Star rating	Comments
The example below highlights a cross-section in Winnininnie that has been improved from a low two-star rating to a moderate three-star rating through the implementation of shoulder widening and the installation of a safety barrier on the outside of the curve.		
Before upgrade (RAA footage, 2013)

★★☆☆☆ (20.59)	<u>Positives</u> <ul style="list-style-type: none"> <li>• Wide lane width</li> <li>• Good pavement condition</li> <li>• No intersections/property access points</li> <li>• Adequate delineation</li> </ul> <u>Negatives</u> <ul style="list-style-type: none"> <li>• Downwards slope 1-5m (LHS)</li> <li>• Narrow sealed shoulders</li> <li>• High speed limit</li> <li>• Moderate curvature</li> </ul>
After upgrade (RAA footage, 2022)

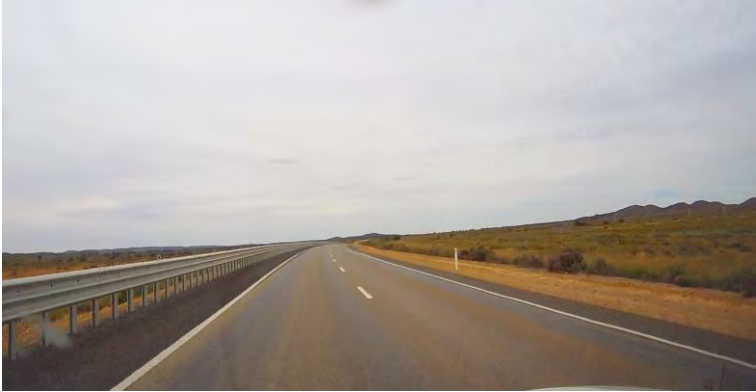
★★★☆☆ (9.39)	<u>Positives</u> <ul style="list-style-type: none"> <li>• Wide lane width</li> <li>• Medium sealed shoulders</li> <li>• Good pavement condition</li> <li>• No intersections/property access points</li> <li>• Adequate delineation</li> <li>• Safety barrier 1-5m (LHS)</li> </ul> <u>Negatives</u> <ul style="list-style-type: none"> <li>• 110km/h speed limit</li> <li>• Moderate curvature</li> </ul>

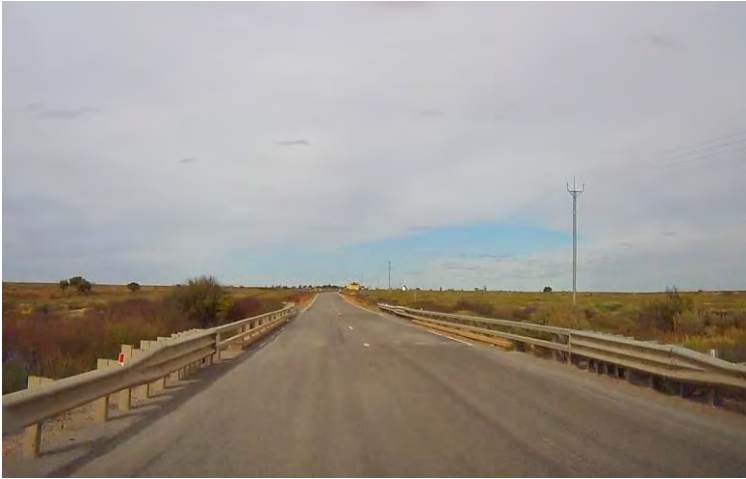
Site coordinates: -32.07914, 140.98361 (heading east)	Star rating	Comments
The below cross-section shows the star rating of a narrow bridge on the approach to Cockburn. Several different barrier systems are used (as is typical for many bridges on the Barrier Highway) which are unlikely to function as effectively as a single, continuous barrier type.

★☆☆☆☆ (30.87)	<u>Positives</u> <ul style="list-style-type: none"> <li>• Wide lane width</li> <li>• Straight section of road</li> <li>• Good pavement condition</li> <li>• No intersections/property access points</li> <li>• Adequate delineation</li> </ul> <u>Negatives</u> <ul style="list-style-type: none"> <li>• 110km/h speed limit</li> <li>• Rigid bridge &lt;1m from edges</li> <li>• No sealed shoulder</li> </ul>

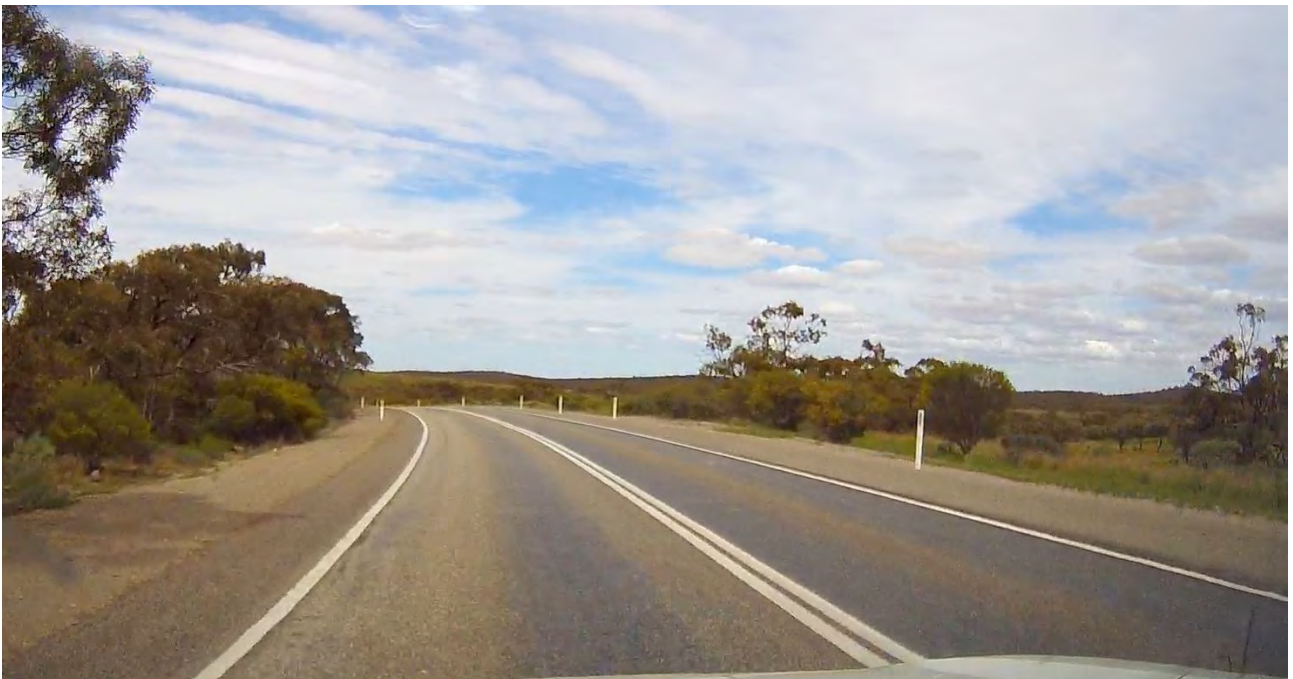
Figure 33: High-risk curves are still present in the area, with this image showing an embankment and trees on the curve

Progressively continue to install safety barriers, focusing on areas with curves and exposed roadside hazards in the hilly terrain between Oodla Wirra and Nackara, and focusing on reducing the frequency of exposed vegetation south of Burra.

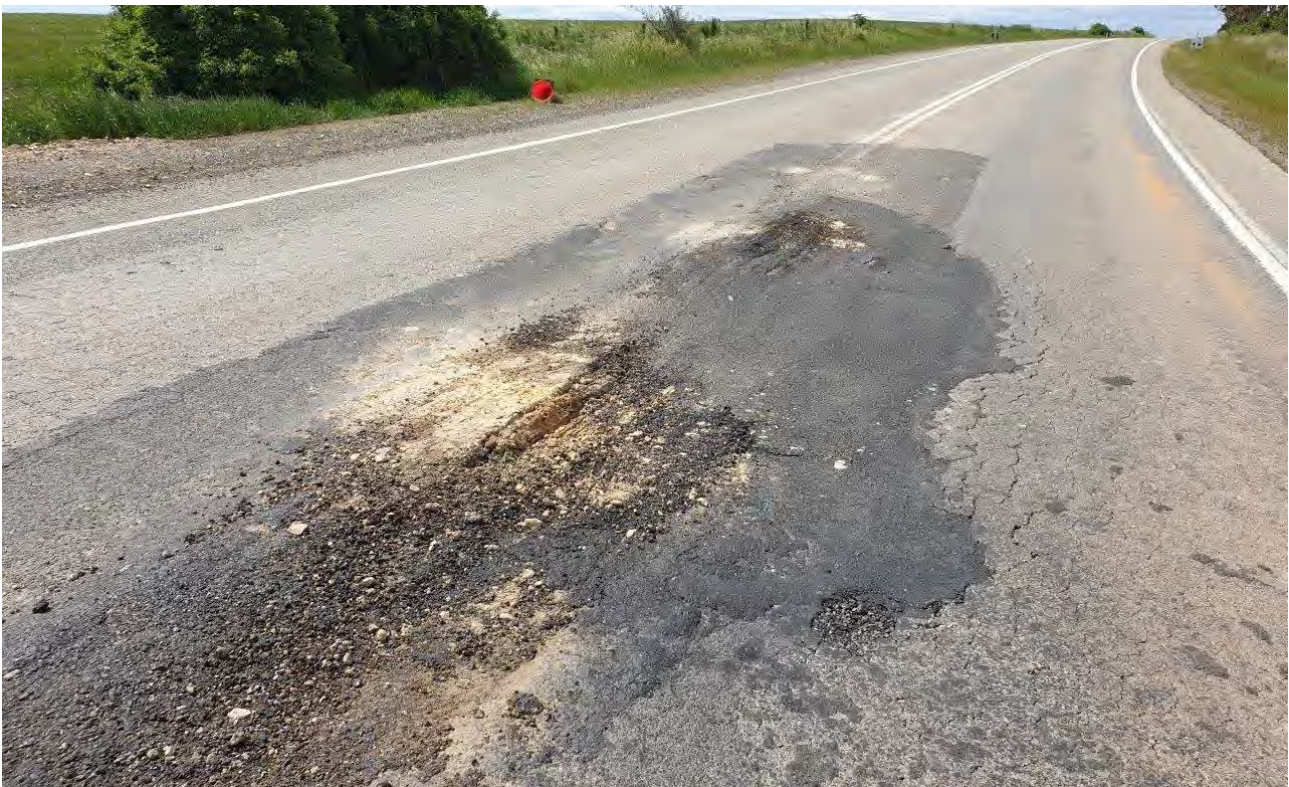
Figure 34: Short-term repairs north of Manoora had significantly deteriorated, with several similar examples experienced between Saddleworth and Black Springs

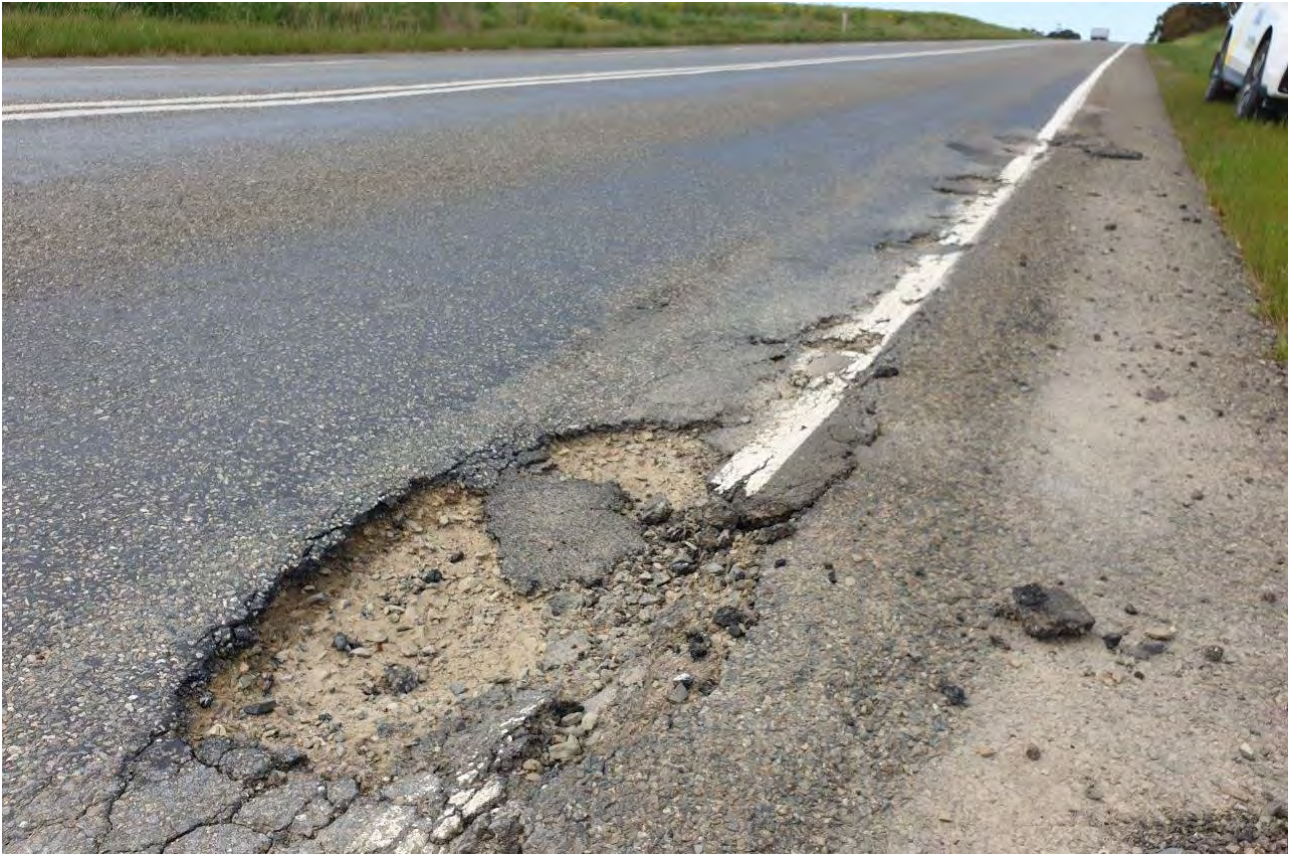
Figure 35: Potholes and fatigue cracking between Saddleworth and Manoora

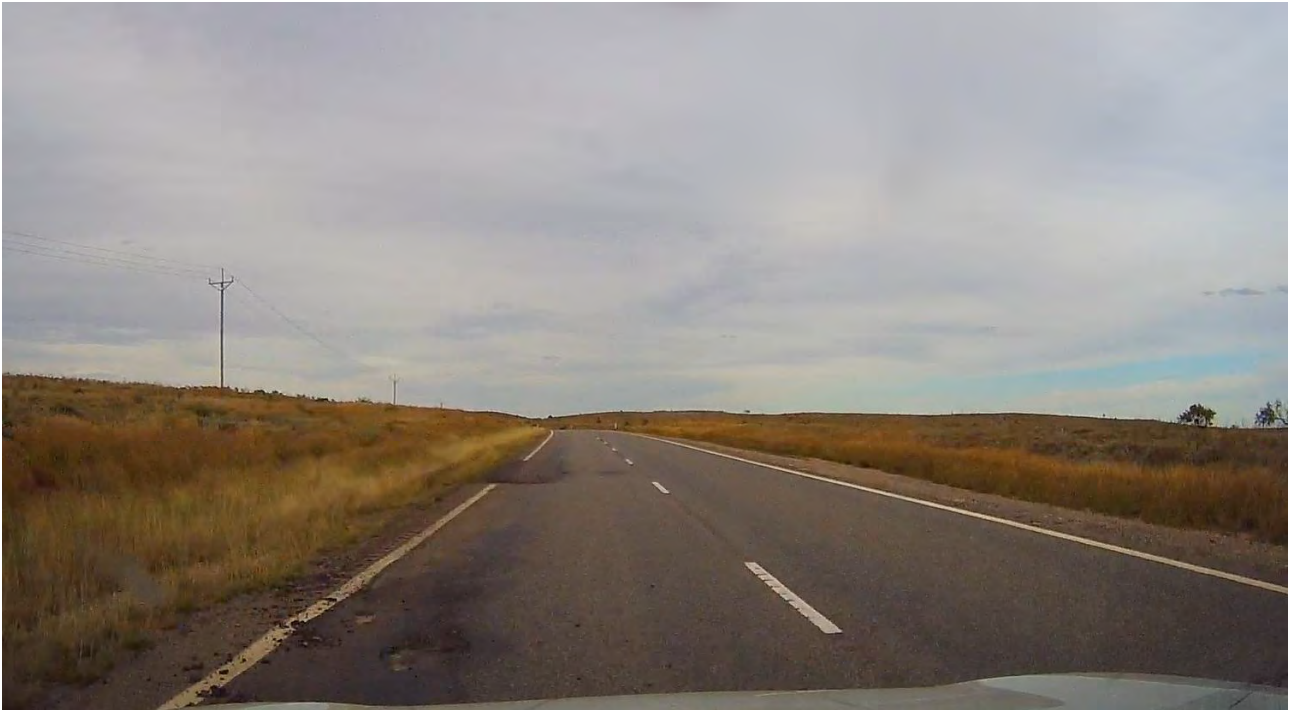
Figure 36: Localised pavement failures leading to potholes between Cockburn and Broken Hill

Undertake localised pavement repairs and resurfacing and widen sealed shoulders between Cockburn and Broken Hill to repair and reduce the occurrence edge break up (Transport for New South Wales).

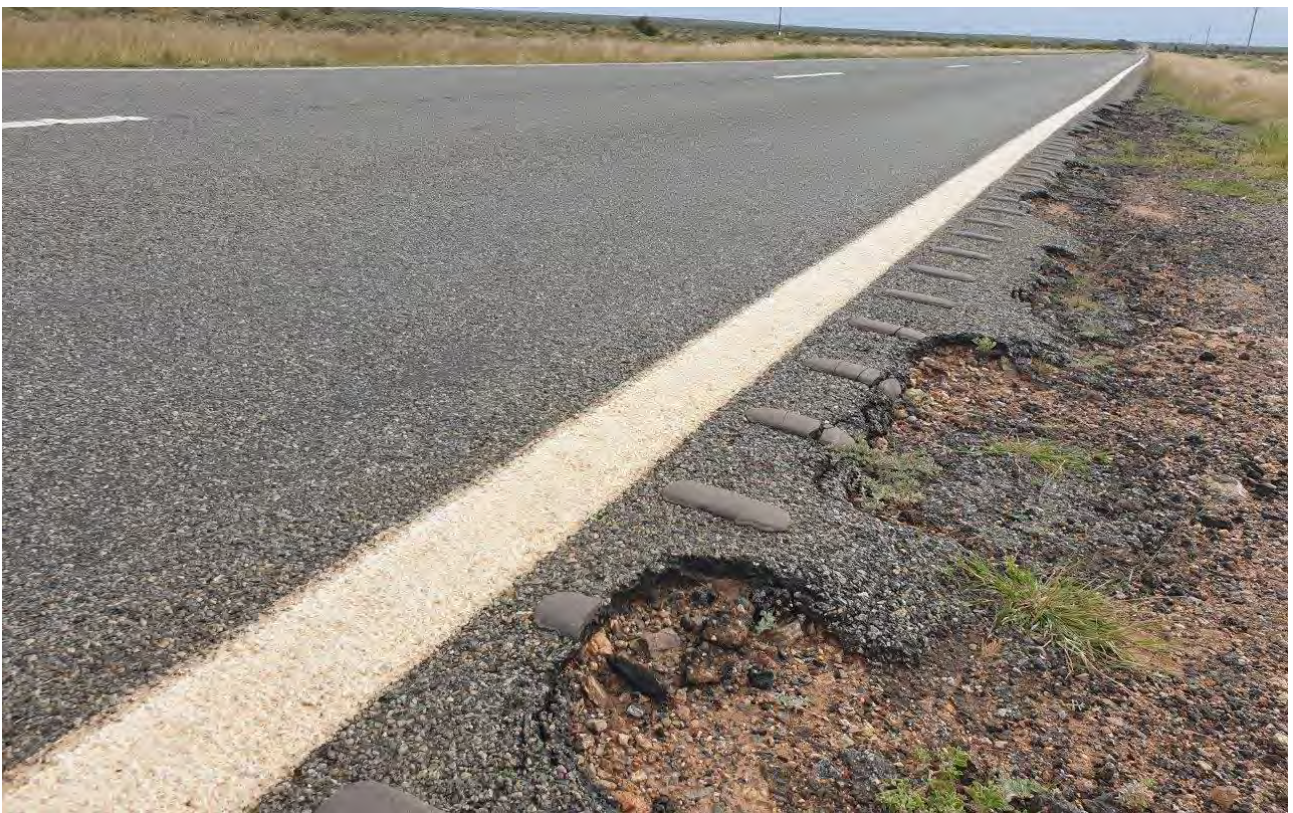
Figure 37: Edge break up between Cockburn and Broken Hill

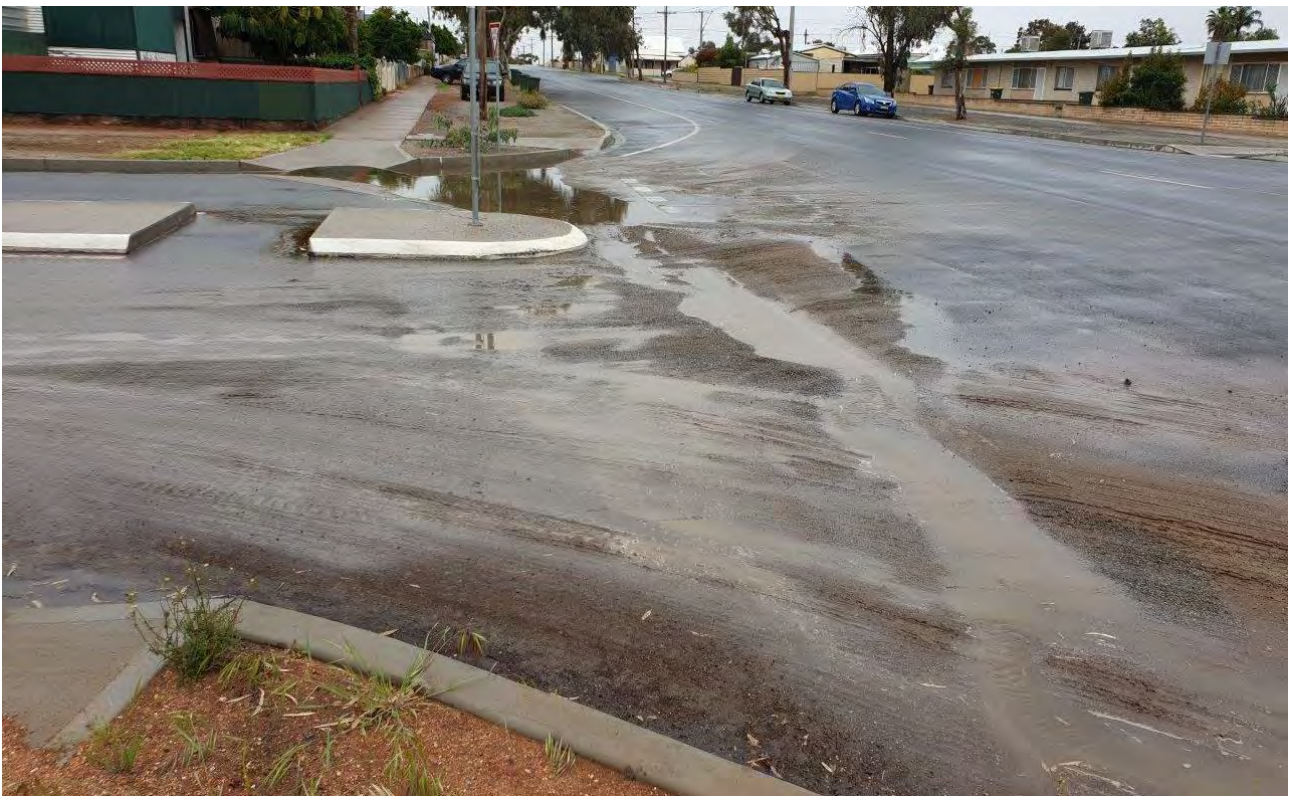
Figure 49: Silt and mud over the road attributable to poor drainage at the Cornish Street/Gypsum Street intersection.

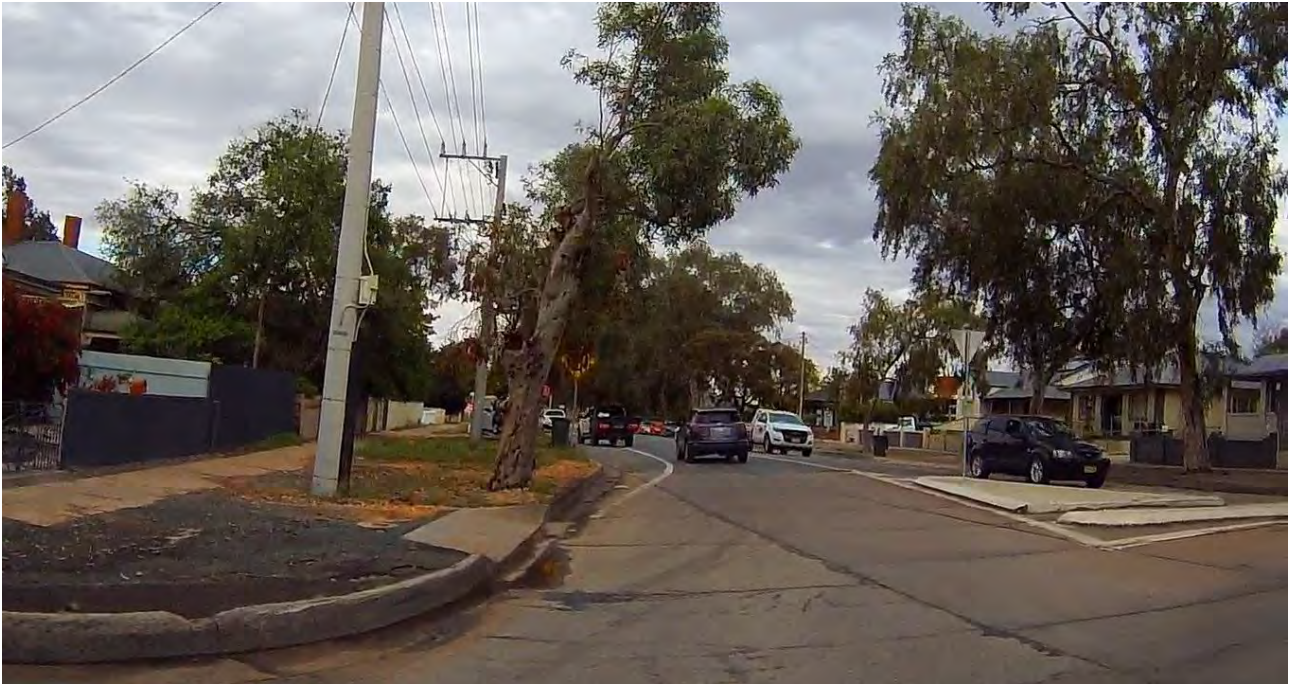
Figure 52: Poor link to splitter island at the Kaolin Street roundabout

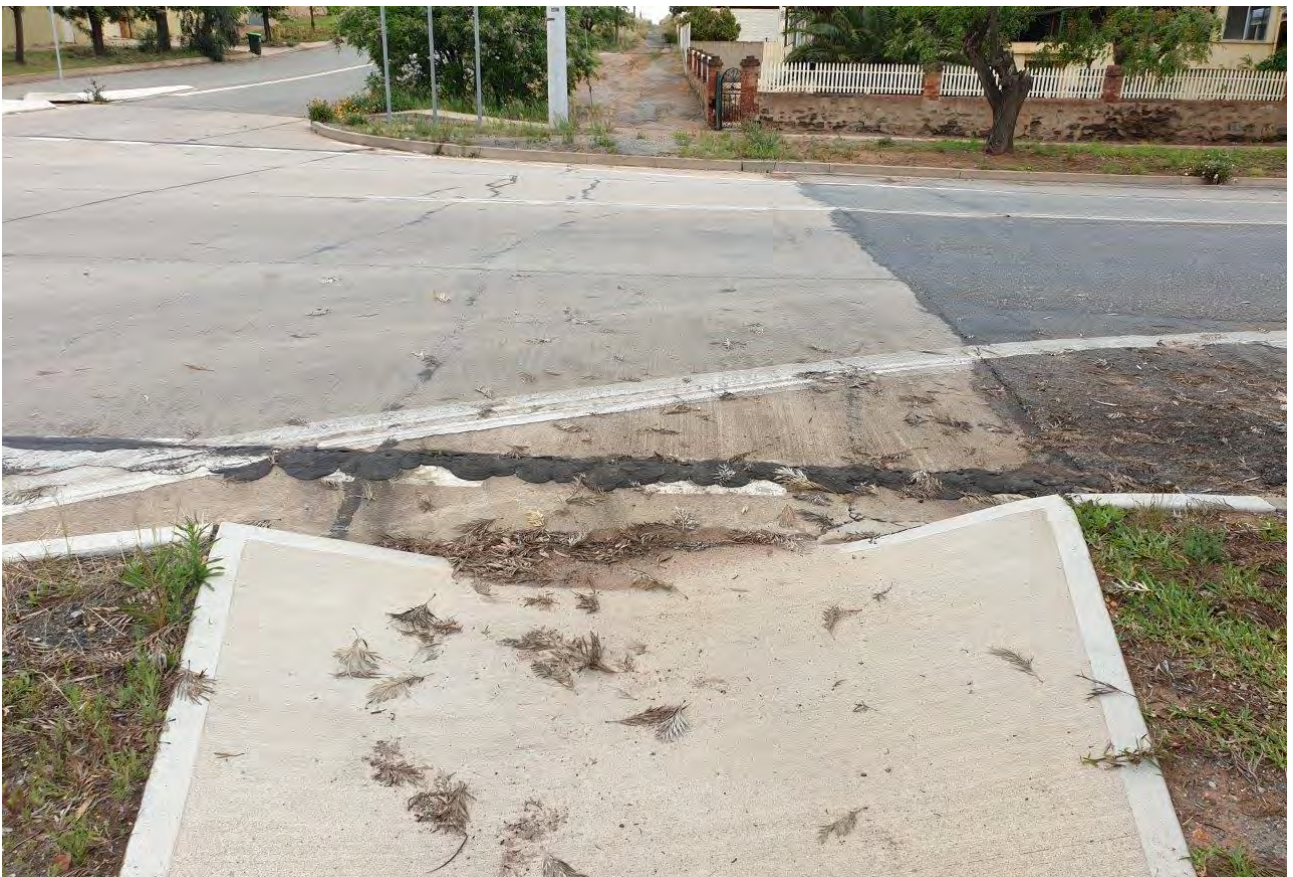
Figure 53: Missing ramp on the north side of Williams Street at the Iodide Street intersection

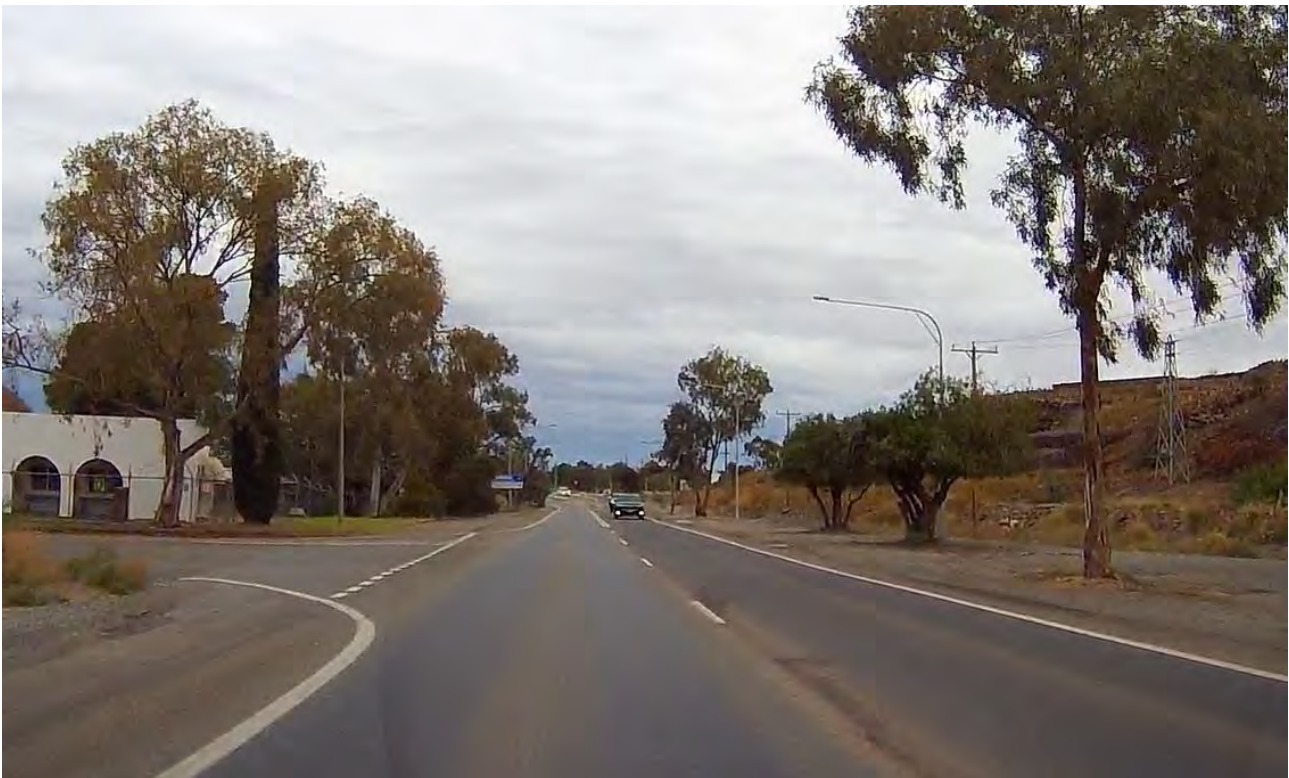
Figure 59: The southwest bound cycle lane is not marked through intersections.

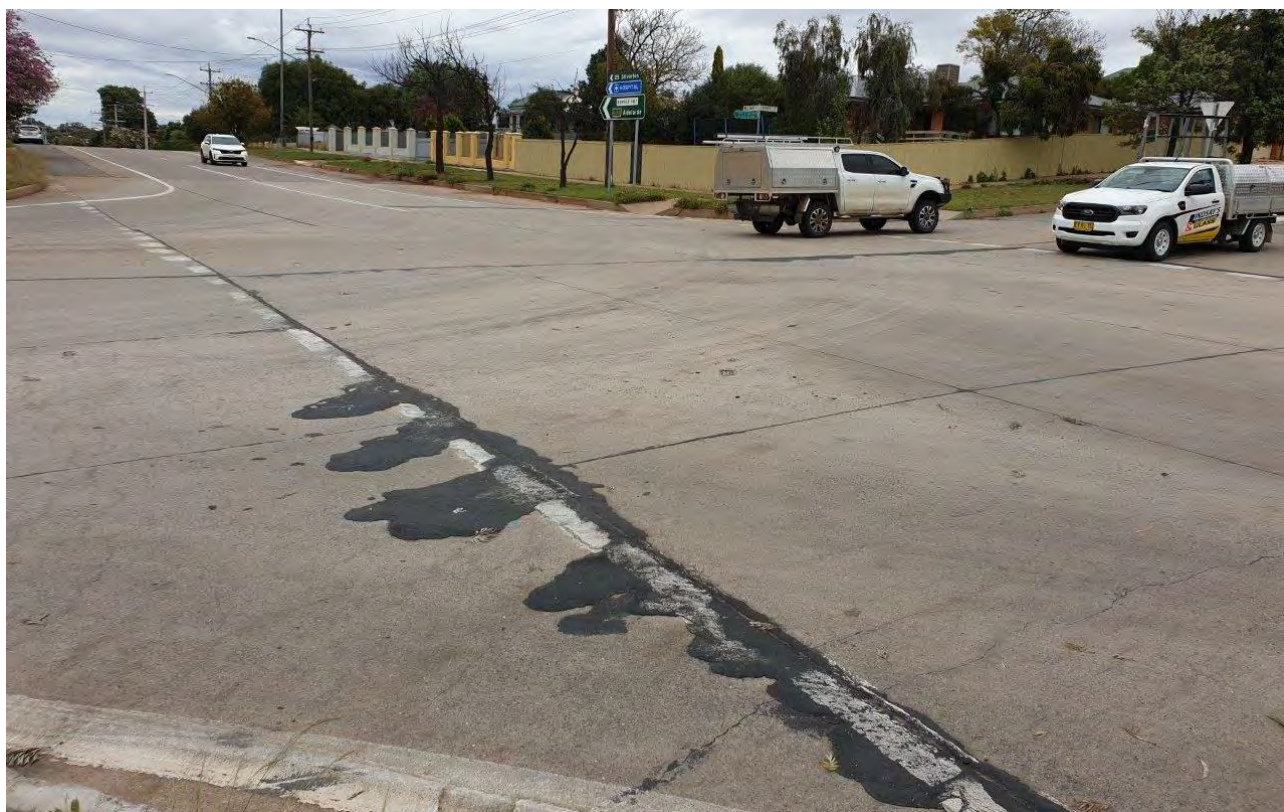
Figure 65: Sealant at cracks and joints in the concrete pavement

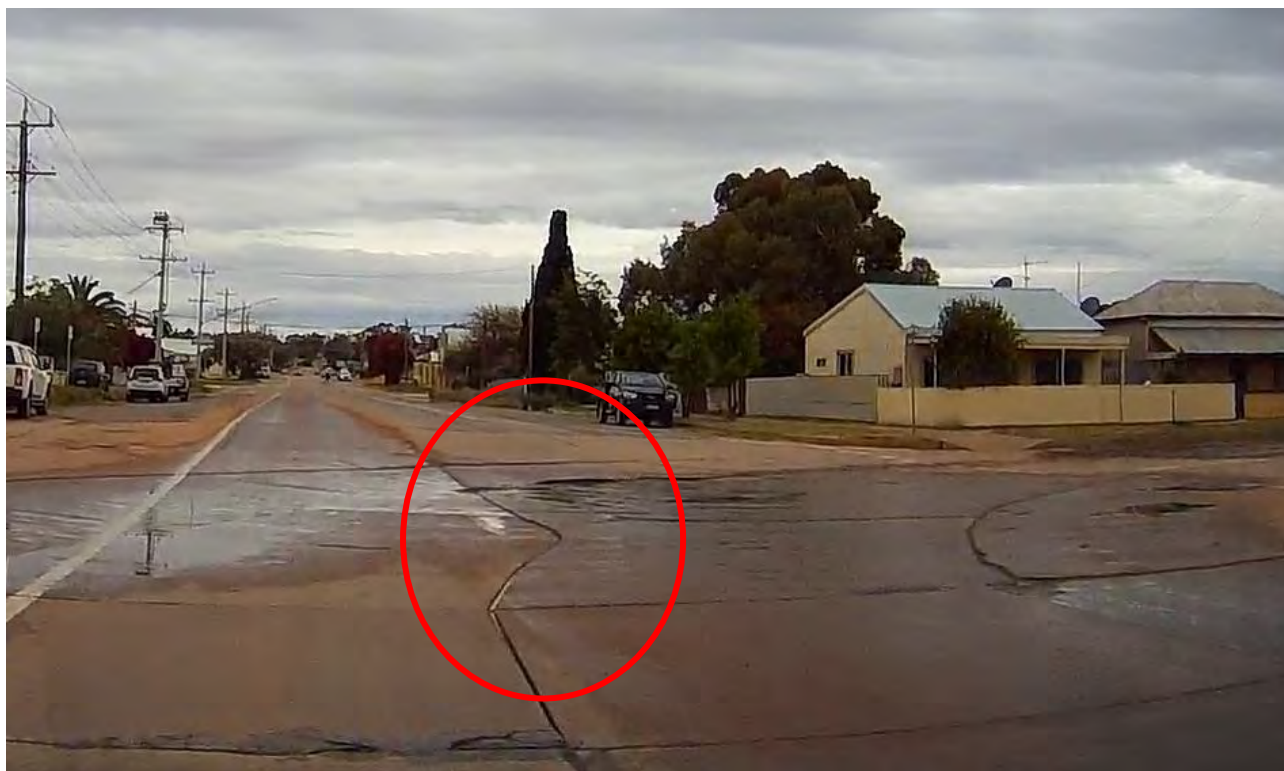
Figure 66: Open transverse expansion joint creating additional risk for motorcyclists and cyclists (Iodide Street/Cobalt Street pictured)

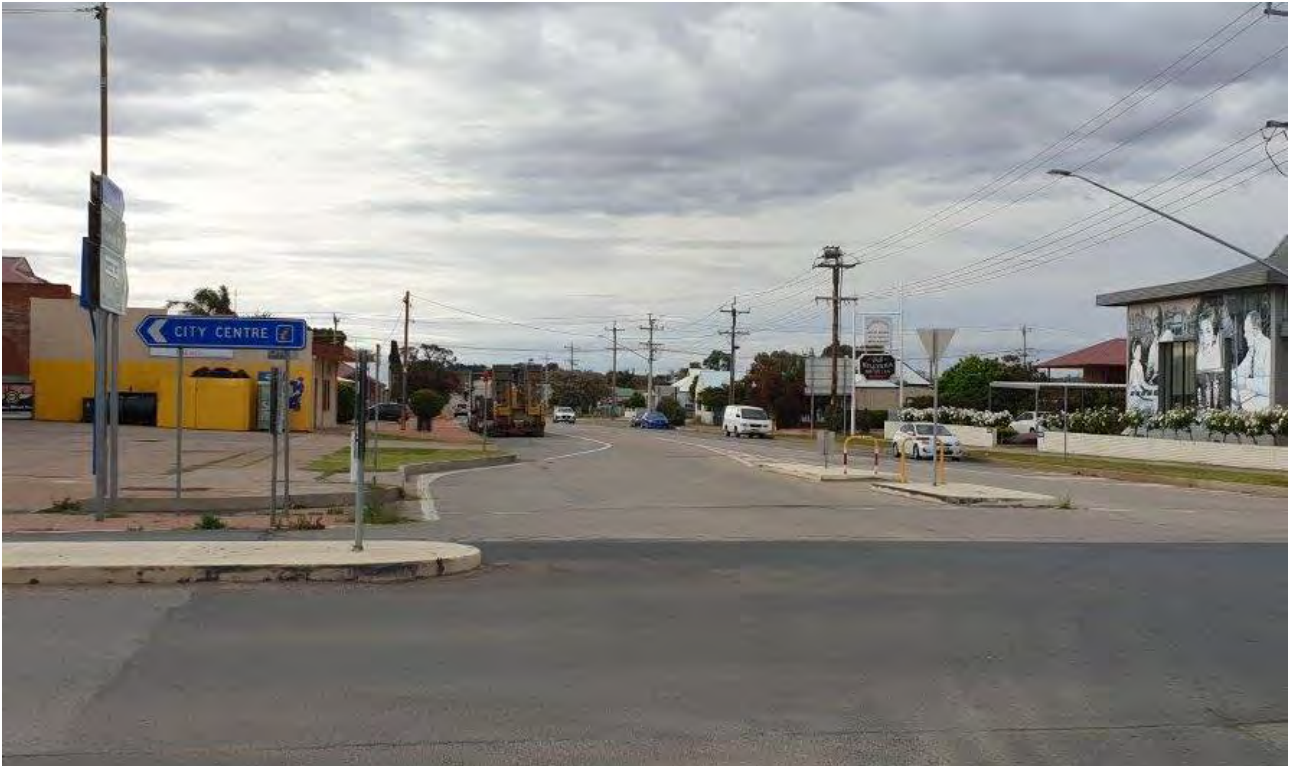
Figure 68: Refuge islands at the intersection with Iodide Street and Argent Street have visible damage due to strikes by turning vehicles.

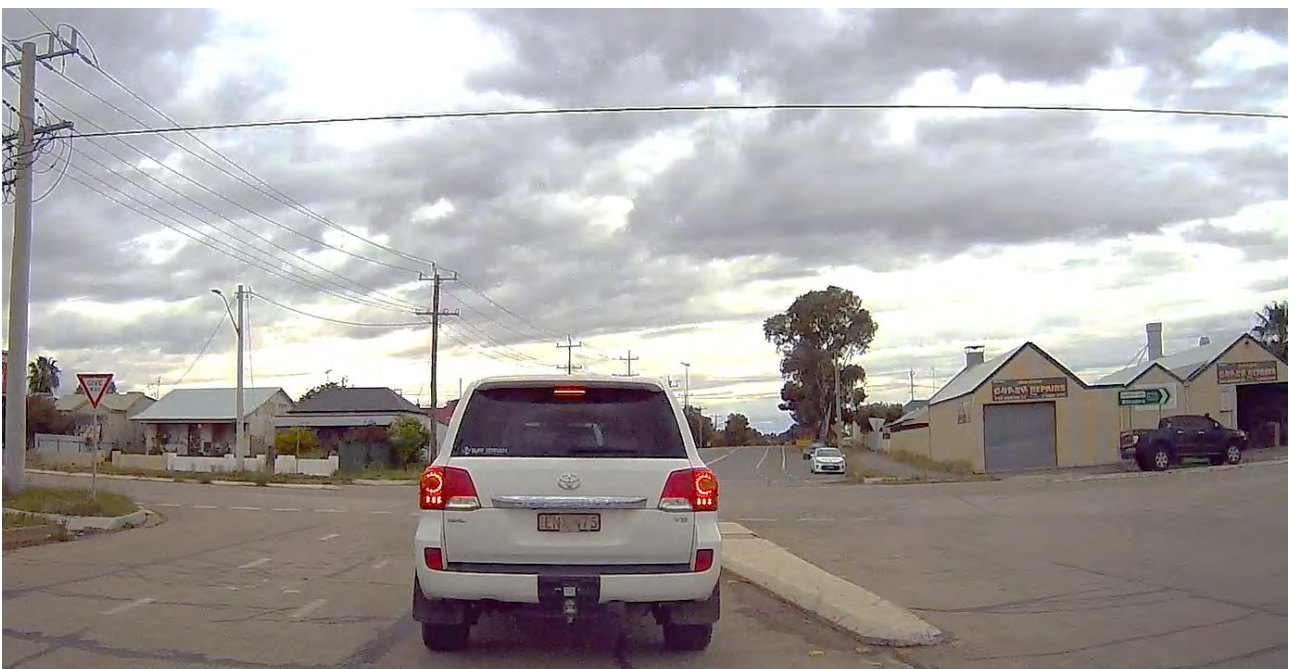
Figure 72: The give way sign is not prominent when approaching Argent Street along Menindee Road.

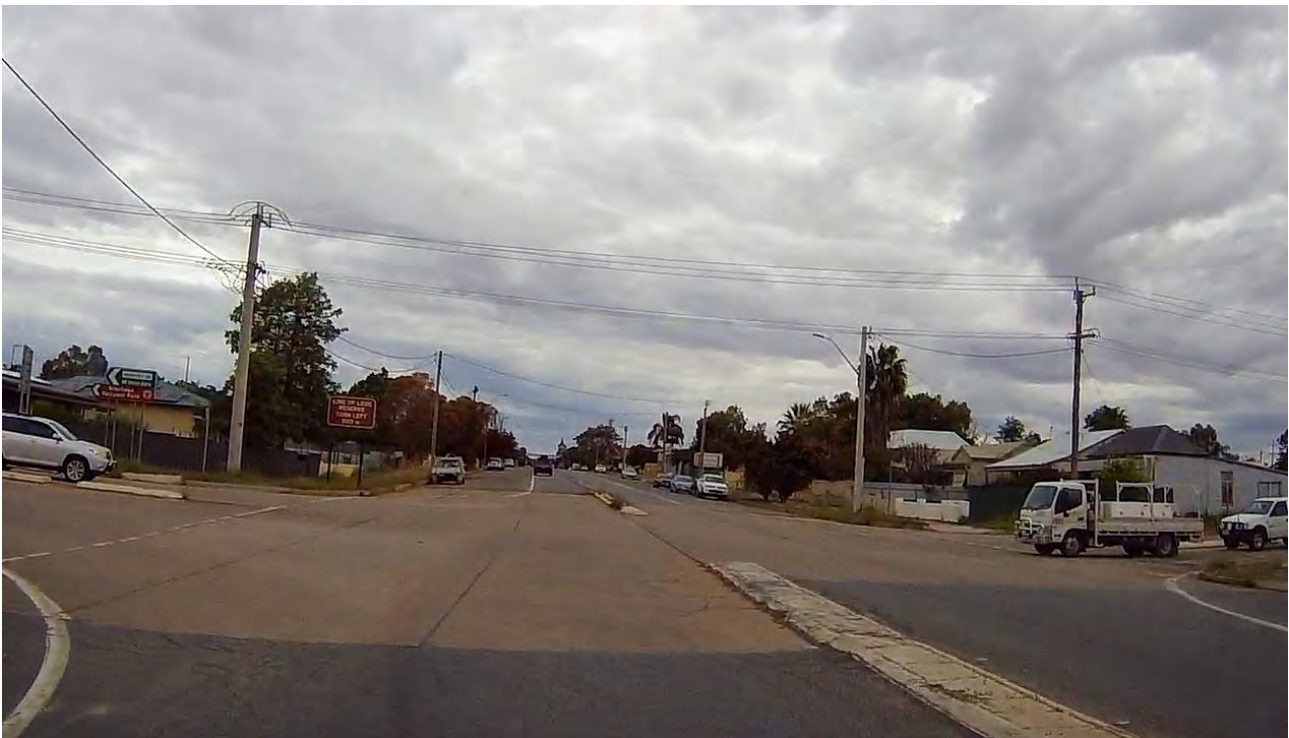
Figure 73: Concrete islands delineate the intersection and are in poor condition due to apparent vehicle strikes

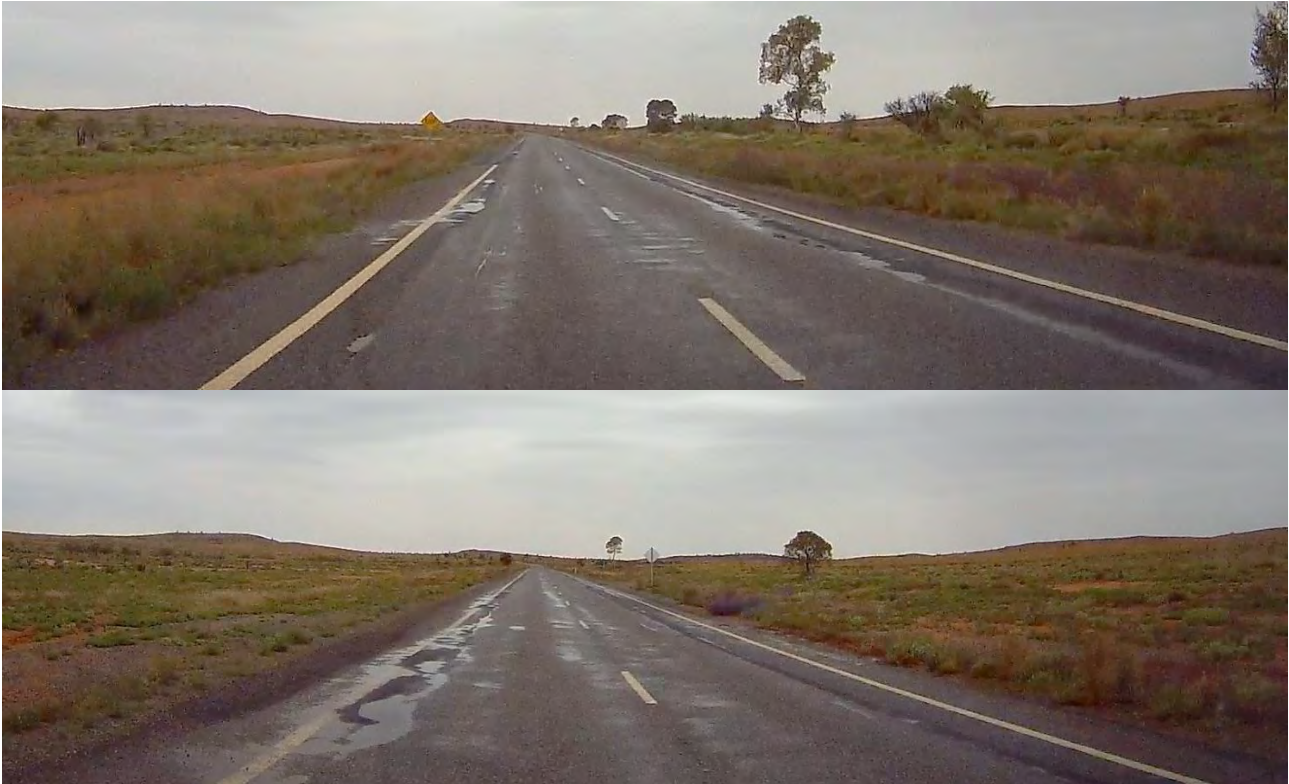
Figure 75: Water ponding on the shoulders and in the join between newly sealed shoulders and the old pavement

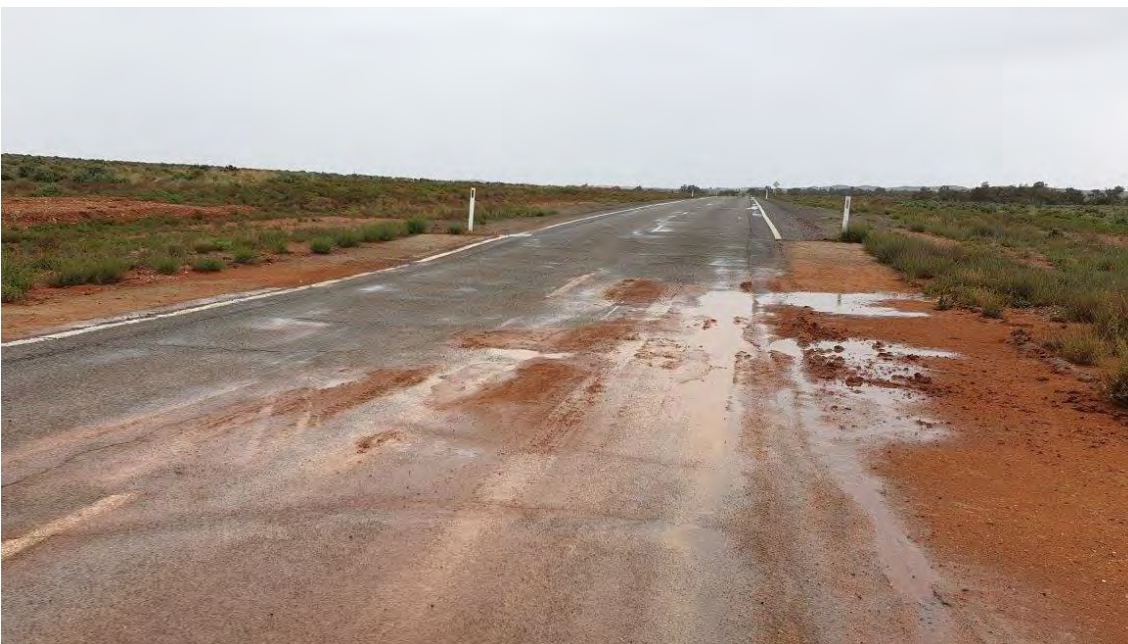
Figure 77: Mud and silt in a floodway over the road after relatively minor rainfall
