# **Regional Road Assessment: Broken Hill and Barrier Highway**

Report – June 2023

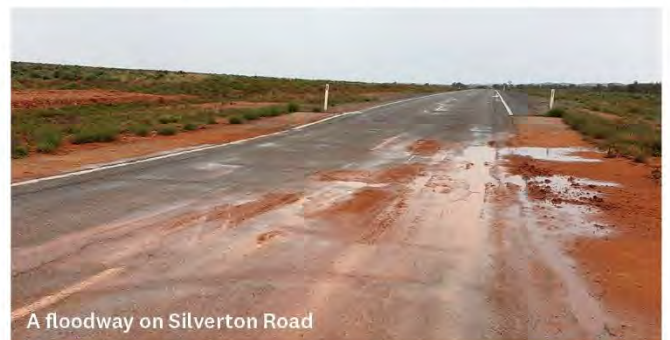
A floodway on Silverton Road

Reseal Silverton Road, considering localised pavement reconstruction and drainage improvements. In the short term, flood depth indicators and associated signage are required at all floodways along the road.

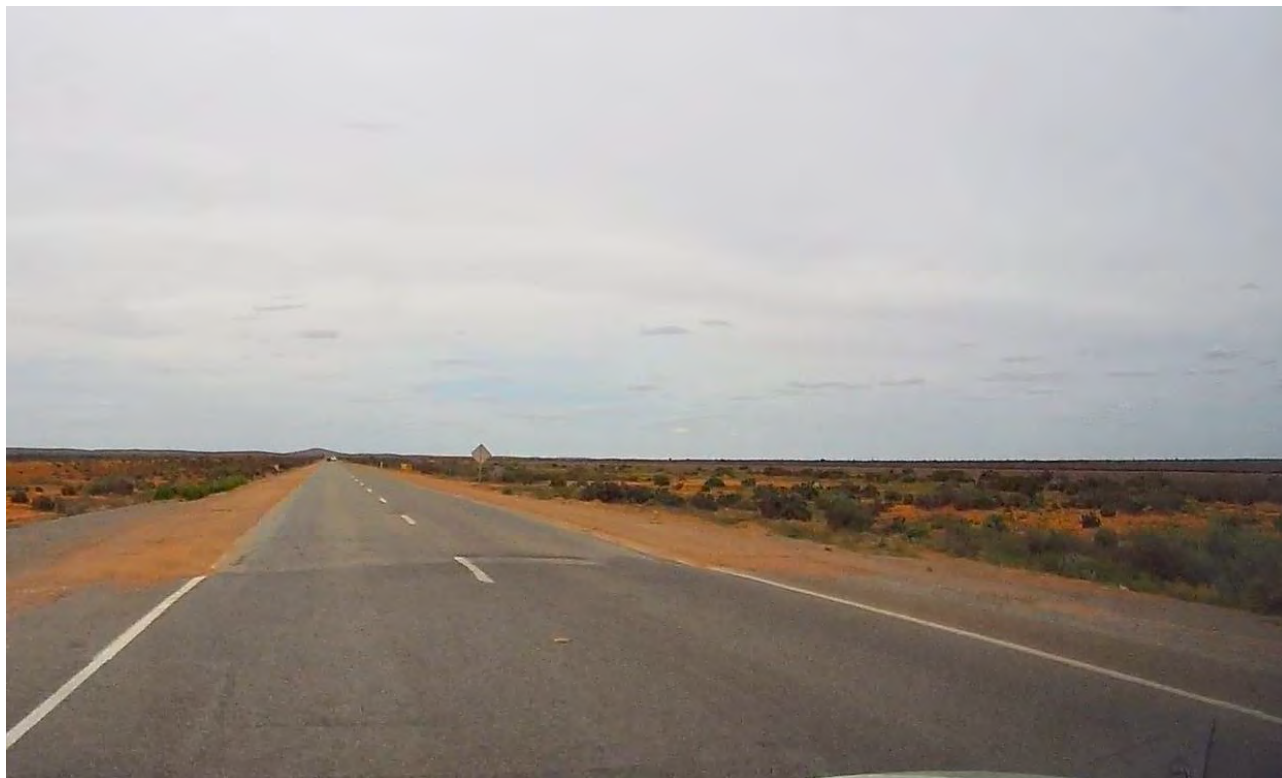
Over the length of Barrier Highway, road widths measured were typically suitable for the purpose of the corridor, largely due to significant investment to widen lanes and sealed shoulders between Burra and Cockburn. Whilst work was ongoing or had not commenced for some sections of the corridor (e.g Manna Hill), the level of improvement on the widened sections was very clear.

Figure 25: Sections where work zones started and finished highlighted the scale of improvements being made

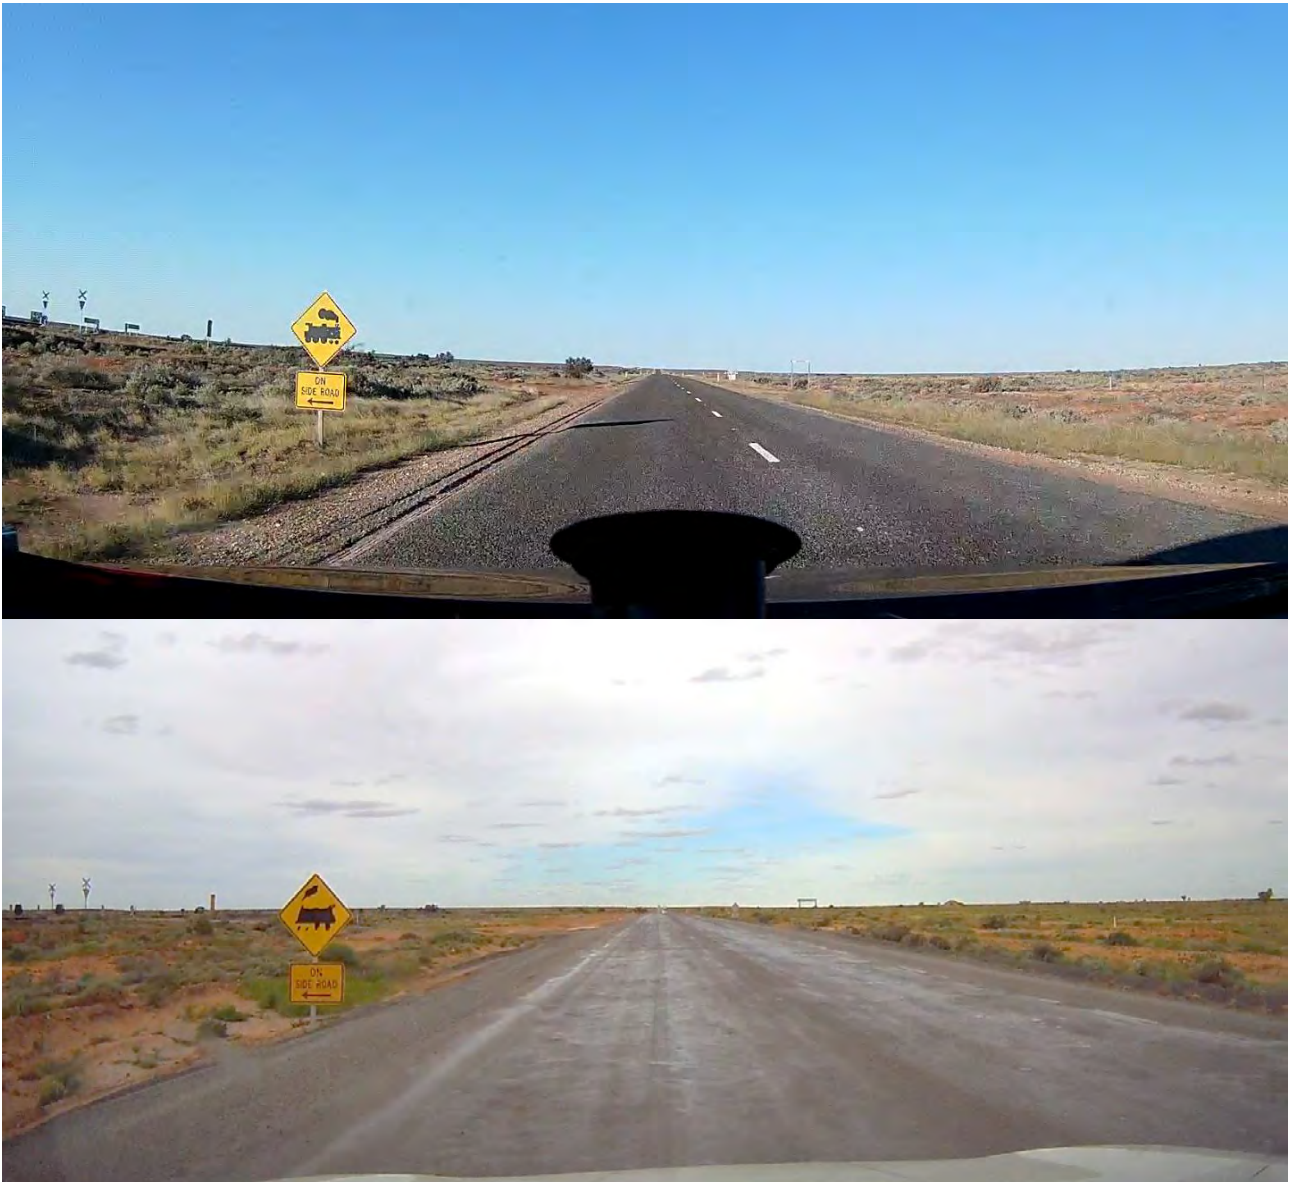
Figure 26: (Top) RAA 2015 footage of Barrier Highway, just west of Wompinie Road (Mingarie) compared with (bottom) 2022 footage of the same location, highlighting the difference in final seal width when widening works are completed.

Widen sealed shoulders to ensure a consistent minimum sealed shoulder width of one metre is provided between Giles Corner and Burra, prioritising the section between Manoora and Burra.

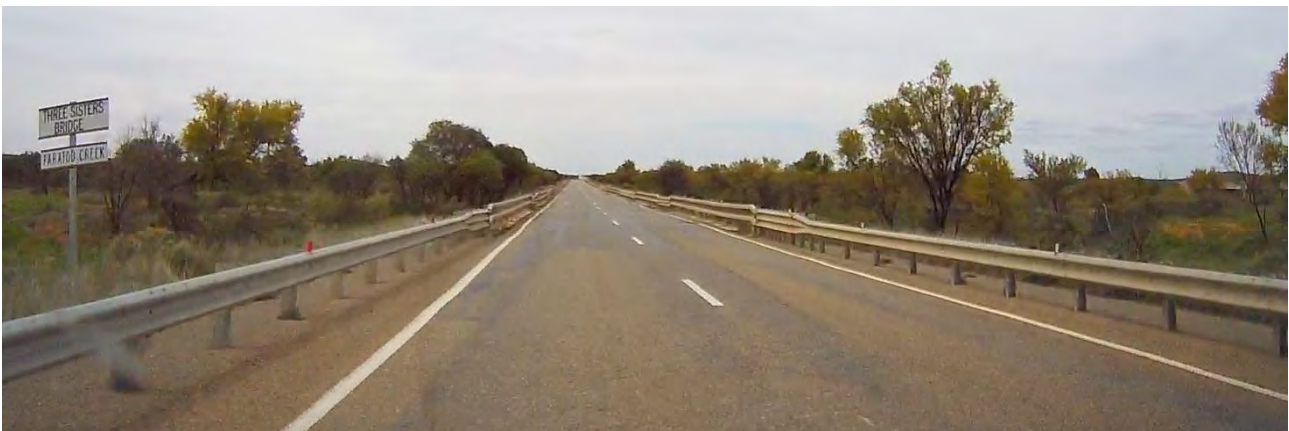
Figure 27: Three sisters bridge, 20km south of Yunta

There are many narrow bridges along the highway, especially between Yunta and Broken Hill. These bridges cause opposing traffic, especially heavy vehicles to pass very closely, whilst bridge ends present a significant roadside hazard in very close proximity to the road. Some of these bridges are close to curves or crests on the road, which limits visibility of the bridge, and to opposing traffic on the bridge. Priority bridges on the highway include (but are not limited to) the:

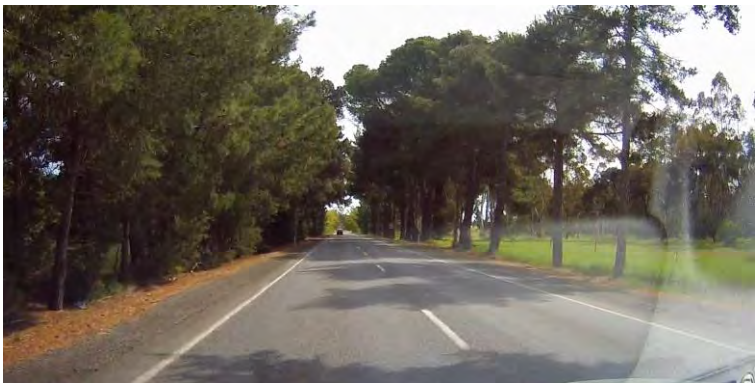
Site coordinates: -34.09230,138.77507 (heading north)	Star rating	Comments
The example below highlights a cross-section south of Saddleworth in the 100km/h zone where trees and property access points are far more frequent than they are further north on the highway. This section could be rated three stars (10.53) with shoulder widening and barriers on one side, or four stars (4.94) with shoulder widening and barriers on both sides. This section would only be rated one-star (24.14) with a 110km/h speed limit.

★★☆☆☆ (18.14)	<p><u>Positives</u></p> <ul style="list-style-type: none"> <li>• Straight section of road</li> <li>• Wide lane width</li> <li>• No intersections/property access points</li> </ul> <p><u>Negatives</u></p> <ul style="list-style-type: none"> <li>• Narrow shoulder width</li> <li>• Trees 1-5m both sides</li> <li>• 100km/h speed limit</li> </ul>
Site coordinates: -33.5945693,138.8913428 (heading south)	Star rating	Comments

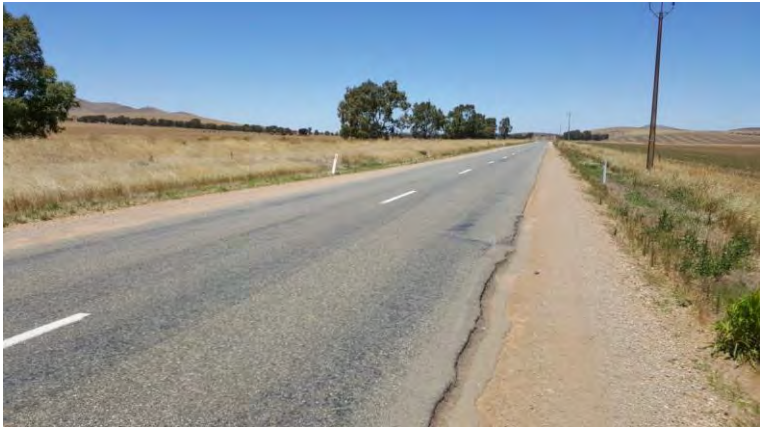
The cross-section below highlights a straight section of Barrier Highway between Burra and Mount Bryan that was recently upgraded to provide wider lanes (>3.25m) and sealed shoulders (approx. 1.0m). Based on RAA's 2018 photo of the site, this section would have received a very low two-star rating of 22.09, whilst following upgrades, the section instead receives a very high two-star rating of 13.32. Installing a barrier to prevent collisions with the stobie pole would further increase star rating to a very high three-star rating of 5.88.		
<p>Before upgrade (RAA photo, 2018)</p>

★★☆☆☆ (22.09)	<p><u>Positives</u></p> <ul style="list-style-type: none"> <li>• Straight section of road</li> <li>• Trees &gt;10m from edge LHS</li> <li>• No intersections/property access points</li> </ul> <p><u>Negatives</u></p> <ul style="list-style-type: none"> <li>• Stobie pole 1-5m from edge (RHS)</li> <li>• Unsealed shoulders</li> <li>• 110km/h speed limit</li> <li>• Poor delineation</li> <li>• Medium lane width</li> </ul>

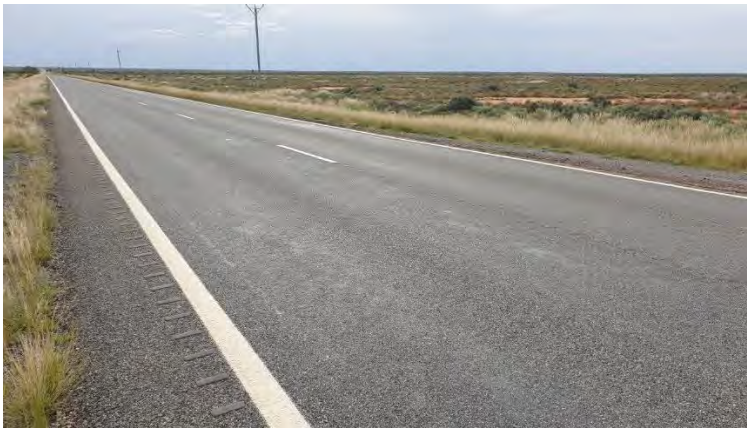
Site coordinates: -32.06112, 141.07266 (heading east)	Star rating	Comments
<p>The example below, in NSW indicates a straight, flat section of road with wide lanes and narrow sealed shoulders (&lt;1.0m). There are stobie poles on one side of the road, set back more than 10m, whilst the other clear zone is free of major hazards. Audio tactile edge and centrelines are also present. This cross section receives a four star rating, however, this would reduce to 3 stars should any fixed hazard be present within 10m of the road edges, or two stars if there are fixed hazards on both sides, and within 5m of at least one side.</p>

<p>★★★★☆ (4.13)</p>	<p><u>Positives</u></p> <ul style="list-style-type: none"> <li>• Wide lane width</li> <li>• Straight section of road</li> <li>• Adequate delineation</li> <li>• Stobie poles &gt;10m from edge</li> <li>• ATLM edge and centre line</li> </ul> <p><u>Negatives</u></p> <ul style="list-style-type: none"> <li>• 110km/h speed limit</li> <li>• Narrow shoulder width</li> </ul>

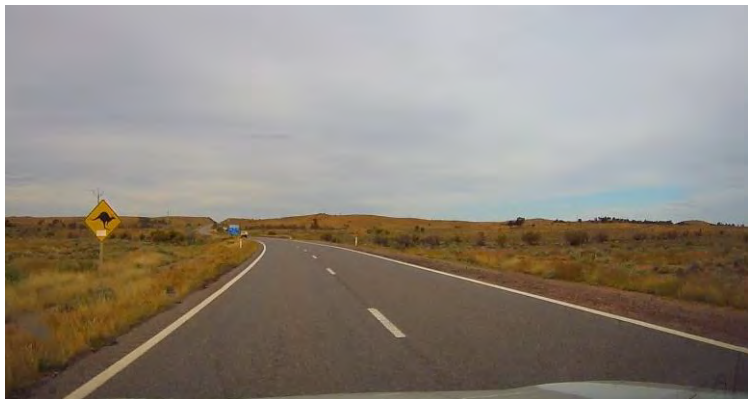
Site coordinates: -32.04925, 141.12202 (heading east)	Star rating	Comments
<p>The example below highlights a similar cross-section to above, but with moderate curvature as the highway traverses the Barrier Ranges on approach to Broken Hill. Whilst there are no significant roadside hazards in this example, any fixed hazard within 10m of the edges would cause the star rating to drop to two stars, whilst hazards within 5m of the edges would see a one-star rating given – highlighting that roadside hazards near curves correlate strongly with low star ratings.</p>

<p>★★★★☆ (6.32)</p>	<p><u>Positives</u></p> <ul style="list-style-type: none"> <li>• Wide lane width</li> <li>• Adequate delineation</li> <li>• No significant hazards within 10m of edges</li> <li>• ATLM edge and centre line</li> </ul> <p><u>Negatives</u></p> <ul style="list-style-type: none"> <li>• 110km/h speed limit</li> <li>• Narrow shoulder width</li> <li>• Moderate curvature</li> </ul>

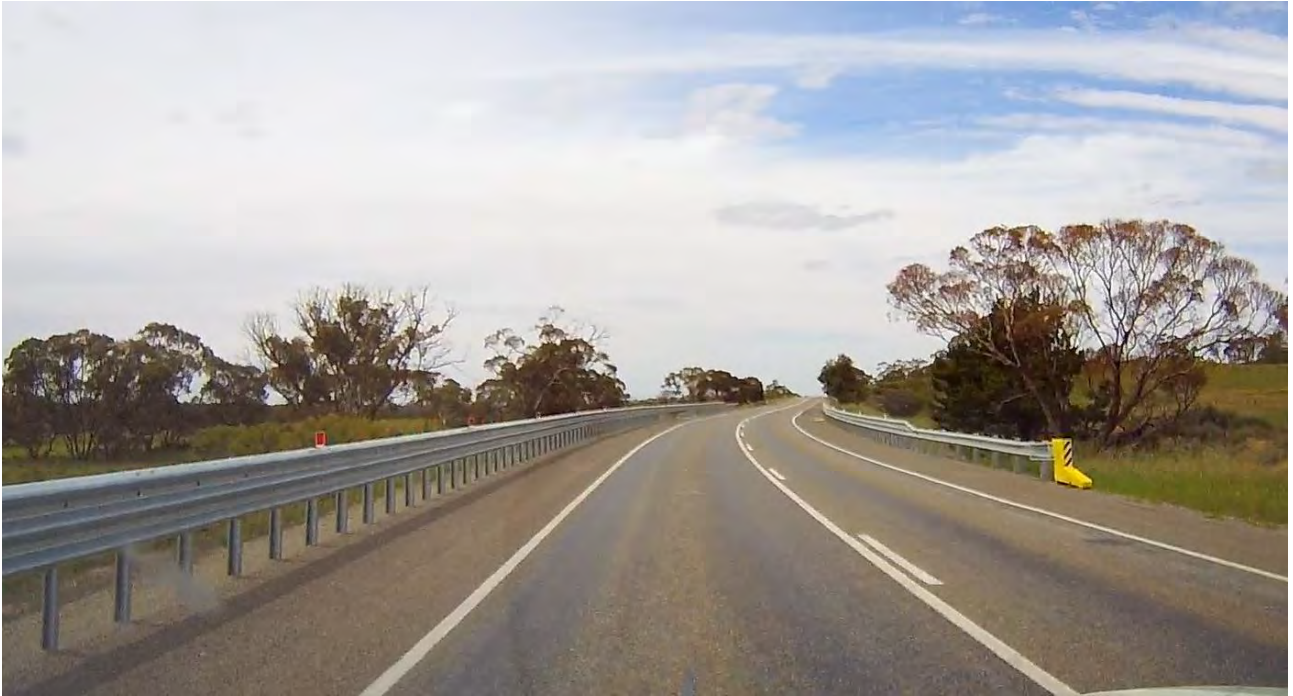
Since RAA's 2013 assessment, there has been a notable improvement in the number of curves treated with safety barriers between Oodla Wirra and Nackara, where the terrain is quite hilly, however, this area still needs to be a focus for continued barrier installations, with many roadside hazards remaining exposed. Exposed trees pose the most significant and frequently occurring roadside hazard south of Burra, and additional barrier protection on this section will reduce the likelihood of fatal and serious crashes involving trees and in most cases result in an incremental star rating increase.

Figure 32: Recent barrier installations in Nackara have provided a welcome improvement to safety on this section

Progressively continue to install safety barriers, focusing on areas with curves and exposed roadside hazards in the hilly terrain between Oodla Wirra and Nackara, and focusing on reducing the frequency of exposed vegetation south of Burra.

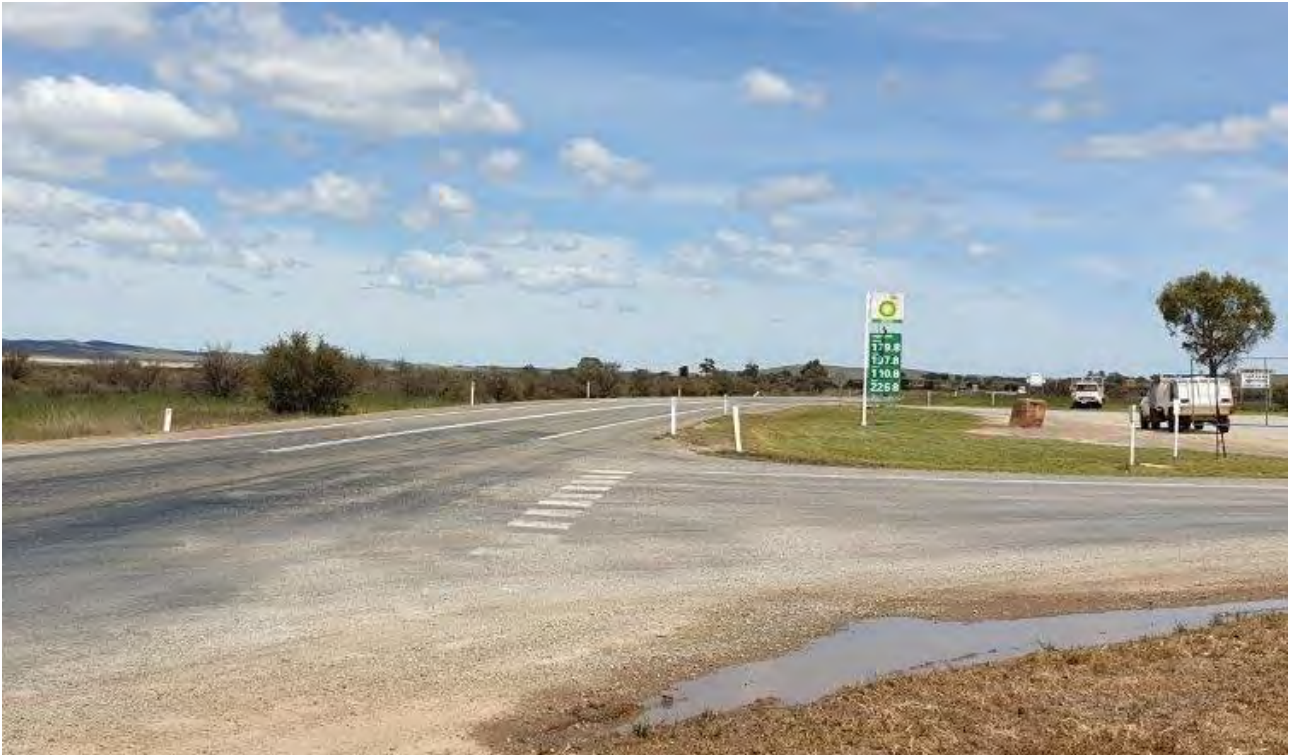
During RAA's site inspection, it was noted that sight distance from Third Street along Barrier Highway to the south was compromised due to the gradual curve in the highway which creates an undesirable observation angle to approaching northbound traffic. Austroads specifies a minimum gap sight distance for vehicles entering from the minor road to be 153m in a 110km/h speed limit zone. This sight distance is currently not met at the intersection and can only realistically be improved via a section of reduced speed limit, should an intersection upgrade and realignment not be considered feasible.

Figure 39: Sight distance along Barrier Highway to the south from Third Street in Terowie

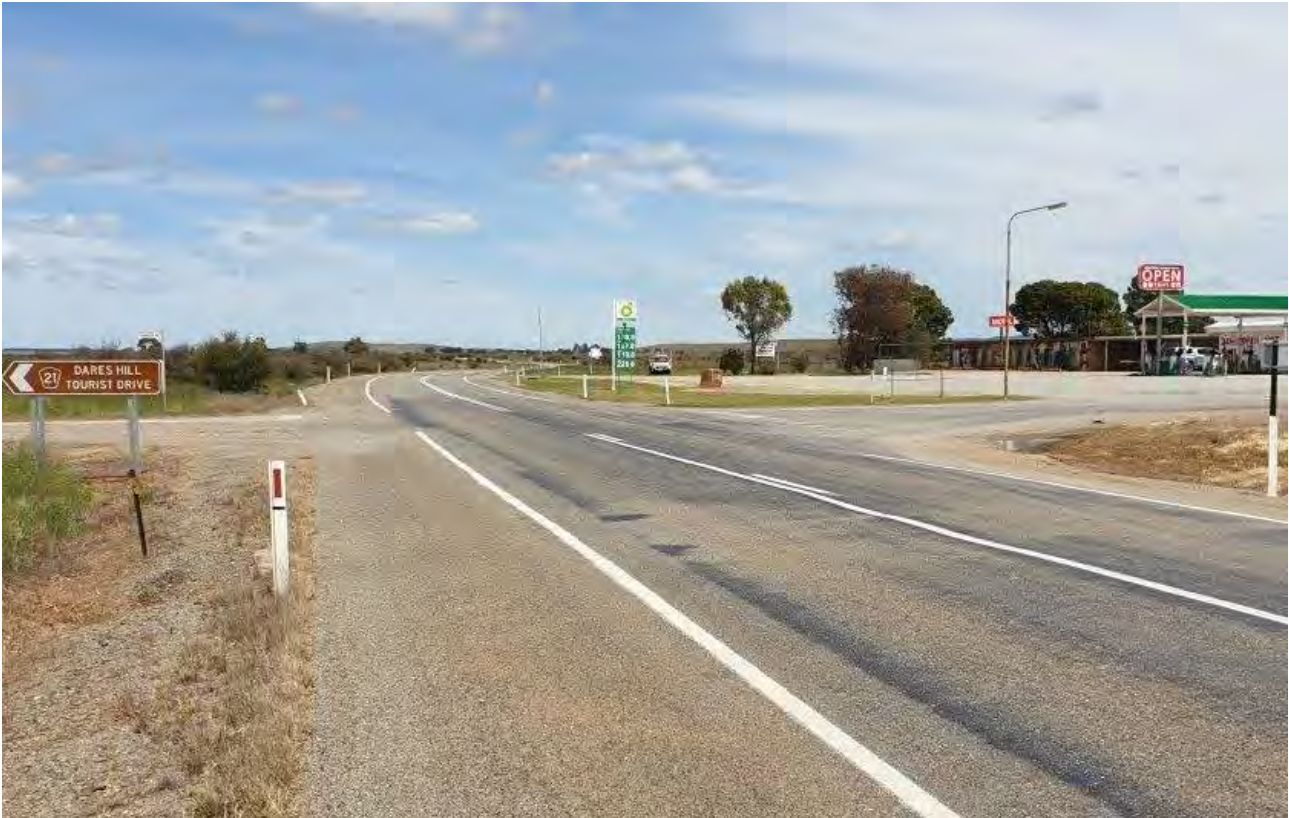
Furthermore, whilst the southbound shoulder has previously been widened, there is limited width for a southbound vehicle to safely pass another southbound vehicle propped to turn right into Third Street, and consideration should be given to further shoulder widening or ideally providing a channelised right turn lane into Third Street. This would further reduce risk, should a vehicle also be entering or crossing Barrier Highway from Franklyn Road.

Figure 40: Widened shoulder on the Barrier Highway through the four-way crossroad at Third Street and Franklyn Road

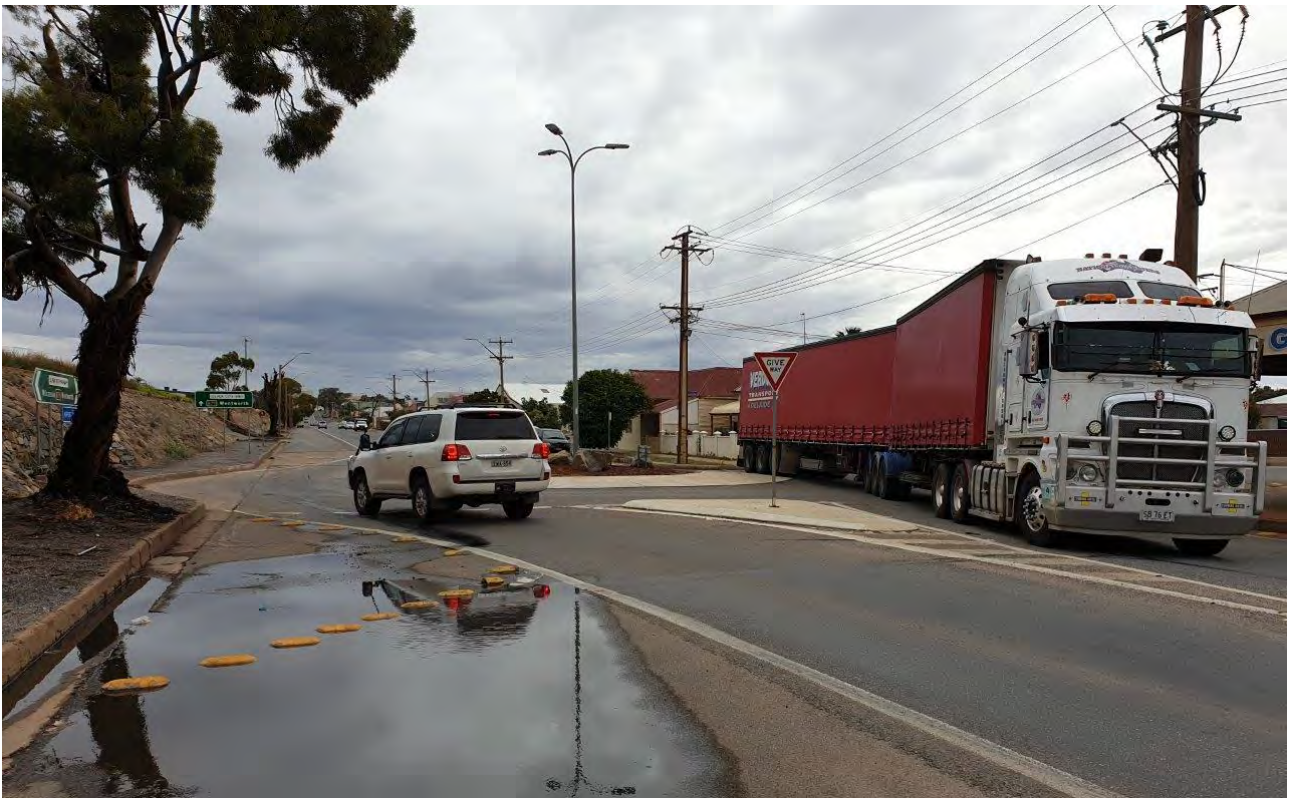
Whilst not always optimal, RAA considers the roundabout design within Broken Hill to be functional. Roundabouts offer a safer and often more efficient alternative to signposted or signalised crossroad intersections. However, roundabouts can introduce challenges for heavy vehicle movements, particularly when left or right turns are required. Observations at roundabouts on freight routes within Broken Hill are that they are augmented with wide concrete aprons which are traversable by large vehicles to account for the swept path of trailers but discourage smaller vehicles from travelling over them.

Figure 48: b-double navigating the roundabout at Crystal Street and Bromide Street

Should a full heavy vehicle bypass of Broken Hill be implemented, additional opportunities to improve intersection and roundabout design across the city would be available. These would include changes to lane width and approach angles (to convert roundabouts from tangential to radial design) as well as improvements to pedestrian accessibility across approach roads.

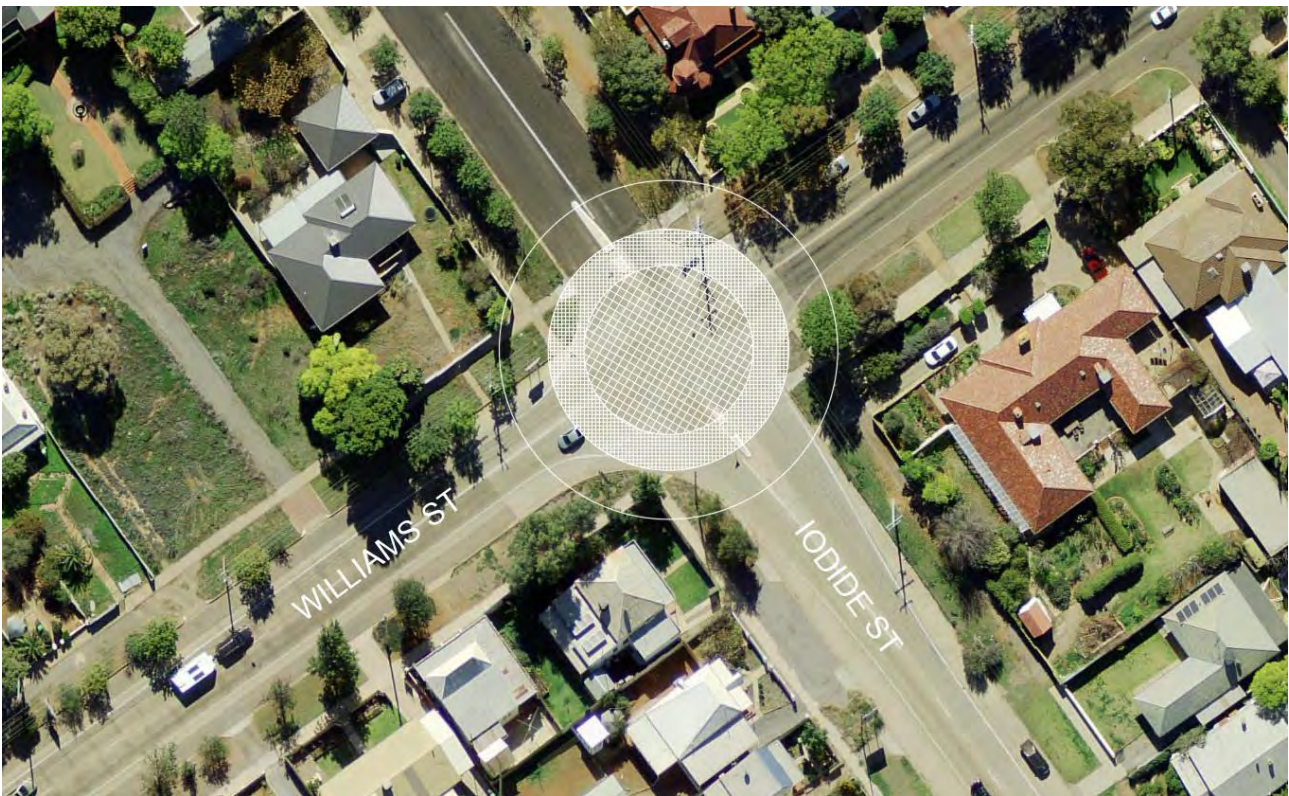
Reviewing b-triple turn paths utilising Austroads templates indicates that the current intersection design only just allows left and right turns for b-triples. It is also possible that any roundabout design would require left turn slip lanes or a wide central island apron to provide adequate width for left turning b-triples. This would be to ensure that the circulating carriageway is not so wide that drivers of smaller vehicles use it like a dual lane roundabout.

Figure 55 highlights an approximate footprint of a 16m radius (including 5m apron) roundabout island at the intersection including a 6m wide circulating carriageway, but before the addition of footpaths, slip lanes, and required modifications to approach and departure legs.

Figure 55: Potential footprint for a roundabout and circulating carriageway facilitating b-triple movements

Given the dimensional constraints to create a roundabout suitable for heavy vehicles at the site, as well as the high cost and limited casualty crash history, RAA considers the current intersection design to suffice in the short to medium term. However, as discussed earlier in this report, a bypass for heavy vehicles would provide opportunities to upgrade this intersection at lower cost with less impact on surrounding property.

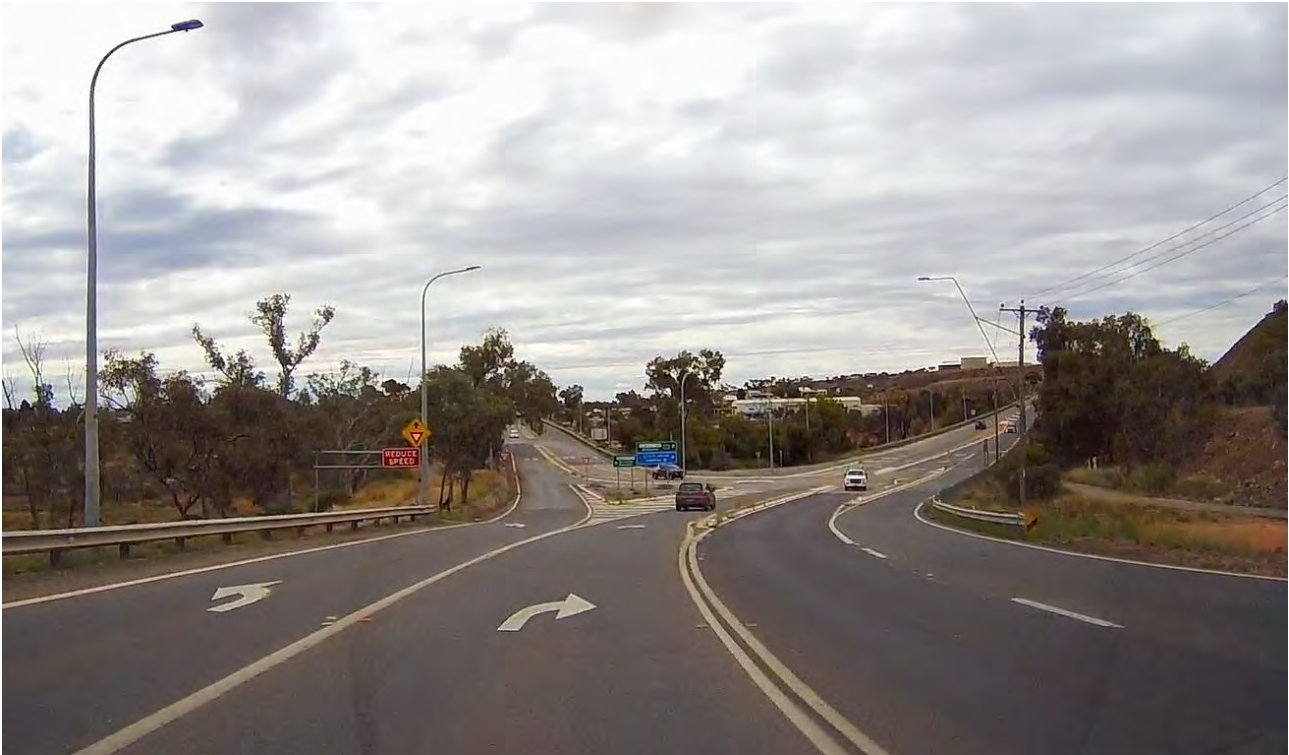
Figure 60: Cycling in the northeast direction as part of a return trip across the overpass is dangerous

A detailed review of this corridor is required to determine opportunities to improve cycle safety, connectivity and route continuity – especially taking into account the need for most cyclists to make a return trip.

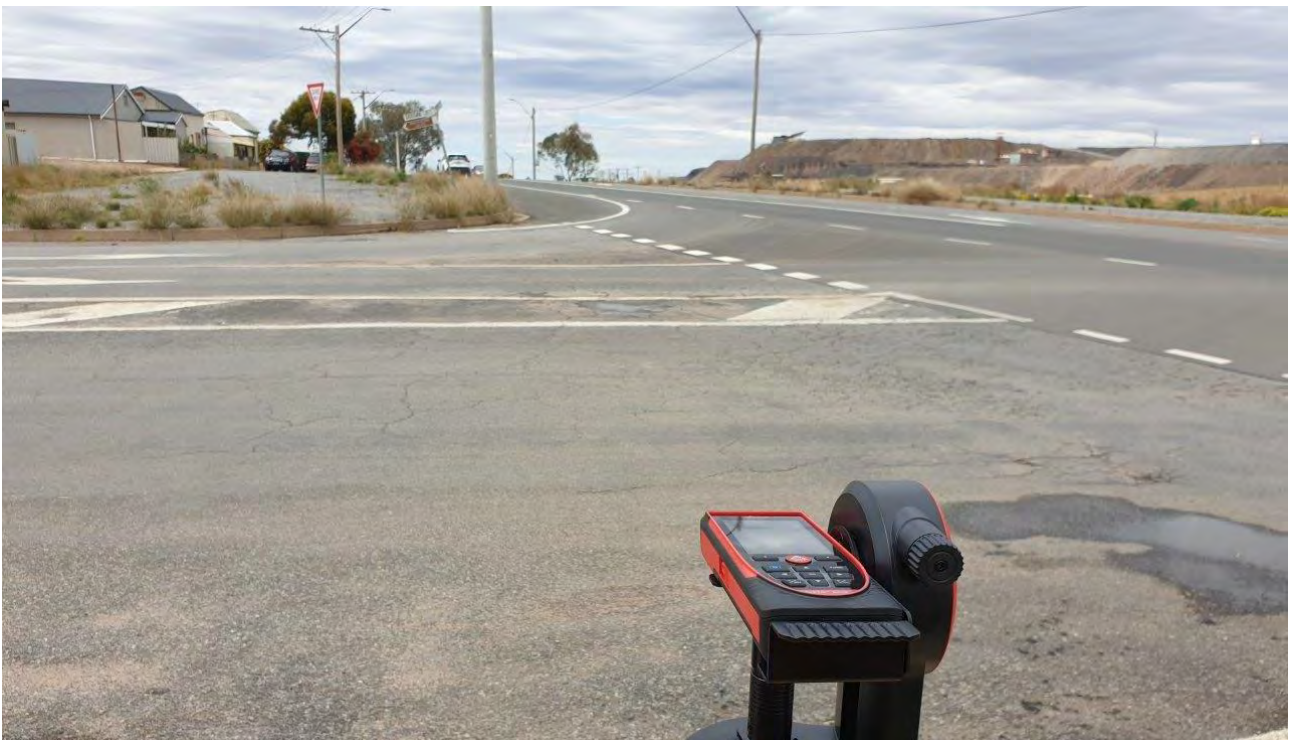
For vehicles entering the road from Gossan Street, the sight distance is slightly higher than the minimum required ‘minimum gap sight distance’ value of 69m specified by Austroads, given a 5 second critical gap acceptance time and a 50km/h 85<sup>th</sup> percentile approach speed.

Austroads also specifies a minimum ‘safe intersection sight distance’ (SISD), that should be provided to vehicles on the through road of vehicles entering the road at an intersection. For a 50km/h design speed and 1.5 second reaction time, and adjusted for grade at this intersection, SISD should be 94m for light vehicles, and 114m for heavy vehicles. These values were not physically checked on-site, however due to the higher position of a heavy vehicle driver, it is possible that this sight distance may be achieved.

Figure 61: Sight distance from Gossan Street along Crystal Street to the northeast is poor

Whilst RAA acknowledges that sight distance should be improved, inexpensive options to achieve this are not available. Reconstructing Crystal Street to remove the crest would resolve the sight distance issue and constructing a roundabout would reduce speeds through the intersection.

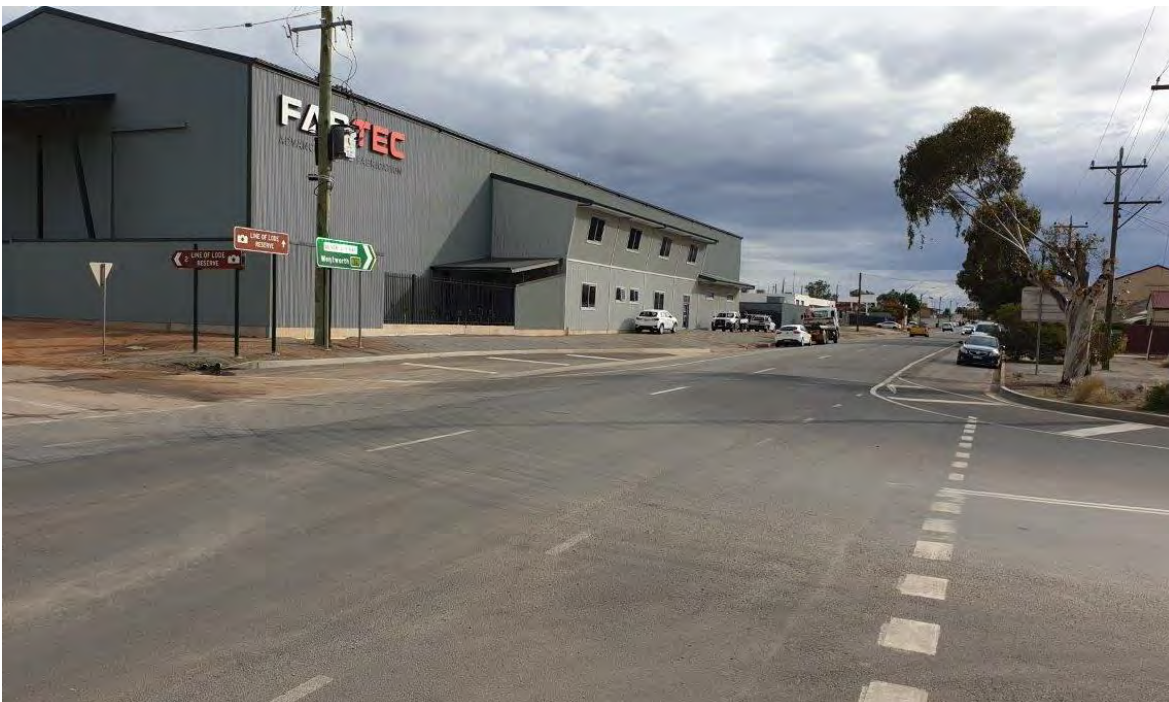
The current intersection design, whilst not optimal, has widened aprons to facilitate heavy vehicle turn movements. Further safety upgrades would be challenging to implement in the somewhat constrained environment unless a Broken Hill freight bypass could be implemented to eliminate major freight movements from the intersection.

Figure 62: The Crystal Street/Iodide Street intersection has wide aprons to facilitate heavy vehicle turn movements.

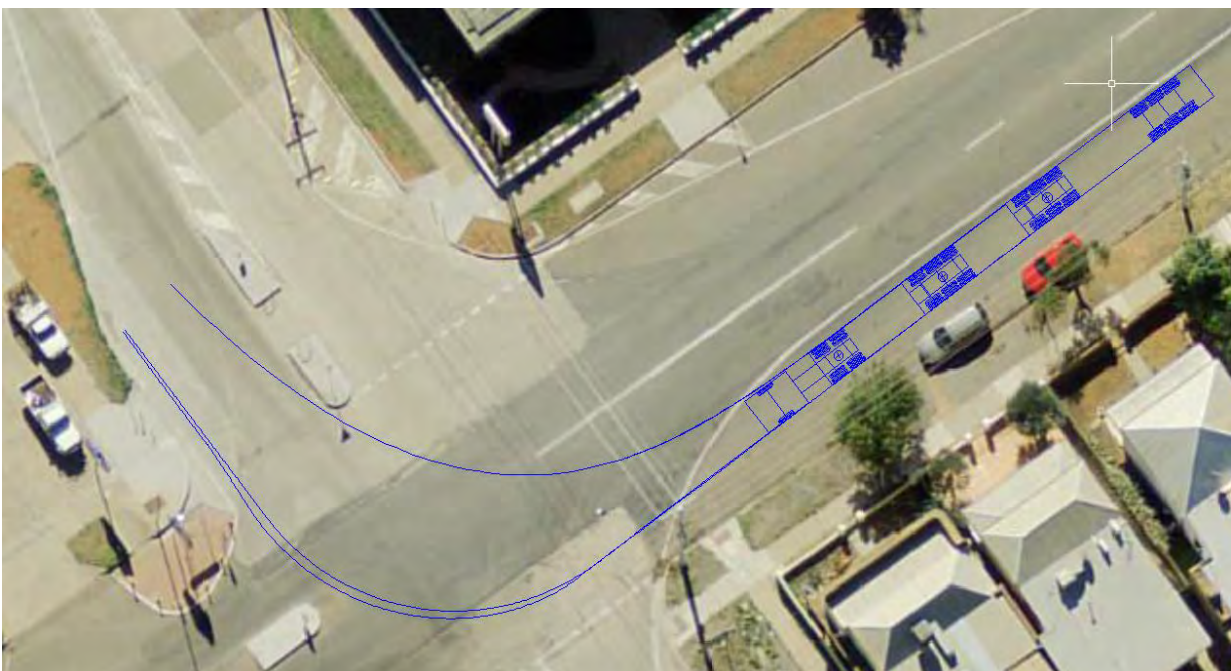
RAA reviewed the intersection, and observed damage to the pedestrian refuge islands, particularly on the northwestern leg of the intersection (Iodide Street) where this is likely hit by trucks turning right from Argent Street onto Iodide Street.

Figure 67 overlays the Austroads b-triple 15m radius turn template over the intersection, with the b-triple shown to be making a 90-degree right turn from the left shoulder of the road. This template uses an indicative turn speed of 5-15km/h and is the best turn path for this vehicle size. Whilst Austroads templates tend to be generous and are limited to a simple 90-degree turn (not considering more complex turn manoeuvres), it highlights how tight this intersection can be for larger heavy vehicles.

Figure 67: Austroads b-triple turn template showing right turn (from the shoulder) from Argent Street to Iodide Street

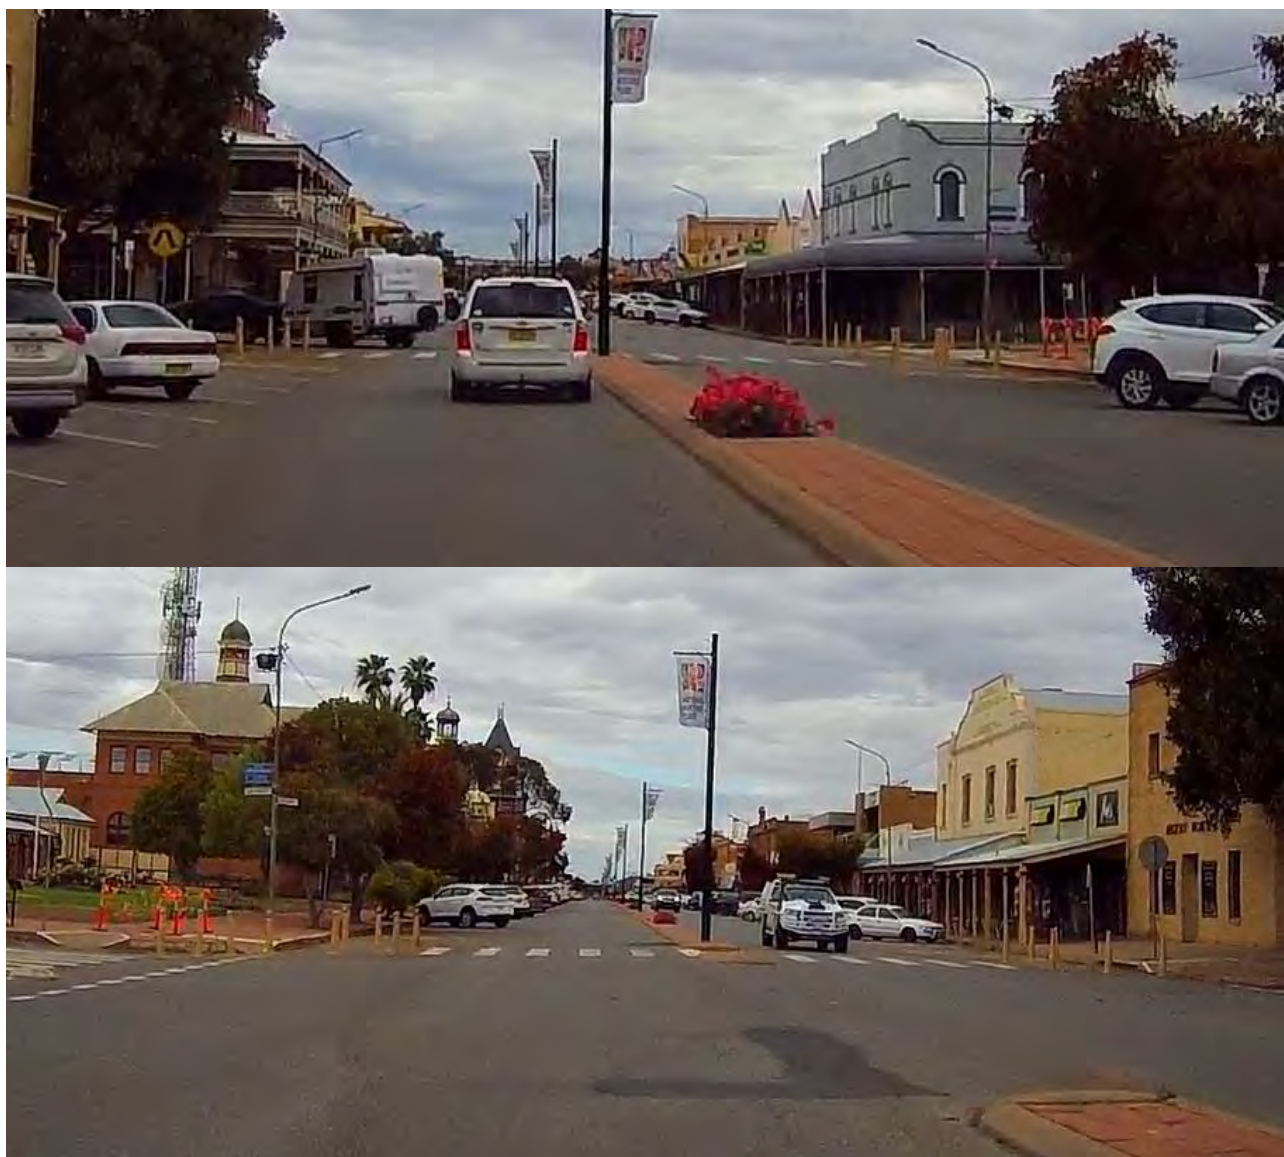
Figure 71: Westbound (top) and eastbound (bottom) approaches to the Sulphide Street zebra crossing

Install duplicated R3-1 pedestrian crossing signs prominently on both approaches to the Argent Street/Sulphide Street zebra crossing.

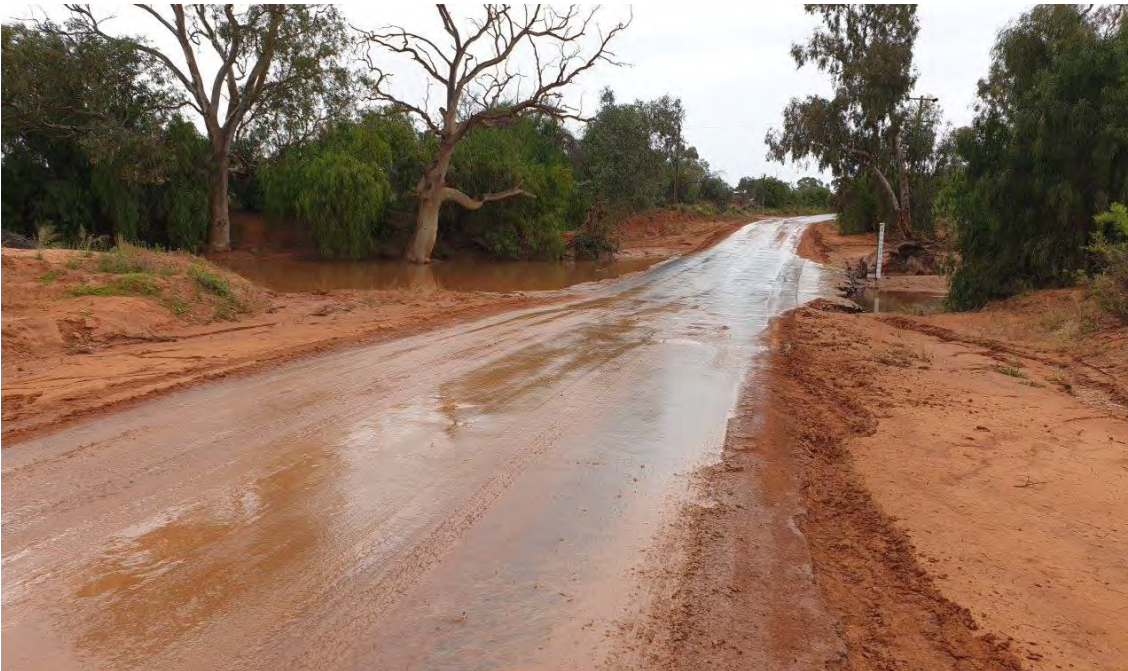
Figure 76: The current Black Hill Creek crossing

In the short term, install G9-22 flood depth indicators at all floodways on Silverton Road, and a G9-21 'ROAD SUBJECT TO FLOODING, INDICATORS SHOW DEPTH' sign prior to the first floodway.

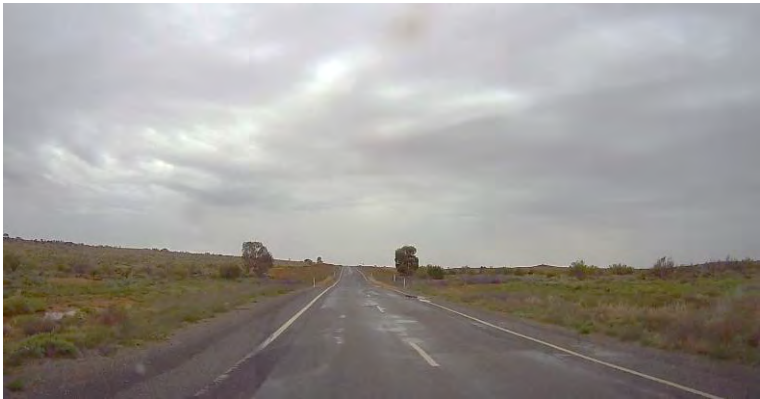
Site coordinates: -31.89962, 141.30263 (heading south)	Star rating	Comments
The example below highlights a straight cross-section of Silverton Road, where trees are more than 10m away from the road edges and there are no other fixed hazards on the roadside. A cross-section like this would typically rate a high three stars at 100km/h or 110km/h, however, due to the 90km/h speed limit, achieves a low four star safety rating.

★★★★★☆ (4.62)	<p><u>Positives</u></p> <ul style="list-style-type: none"> <li>• Straight, flat section of road</li> <li>• Medium lane width</li> <li>• Medium sealed shoulder width</li> <li>• Low traffic volume</li> <li>• No intersections/property access points</li> </ul> <p><u>Negatives</u></p> <ul style="list-style-type: none"> <li>• Poor pavement condition</li> <li>• Trees &gt;10m away from edges</li> <li>• 90km/h speed limit</li> </ul>
Site coordinates: -31.93693, 141.41054 (heading south)	Star rating	Comments

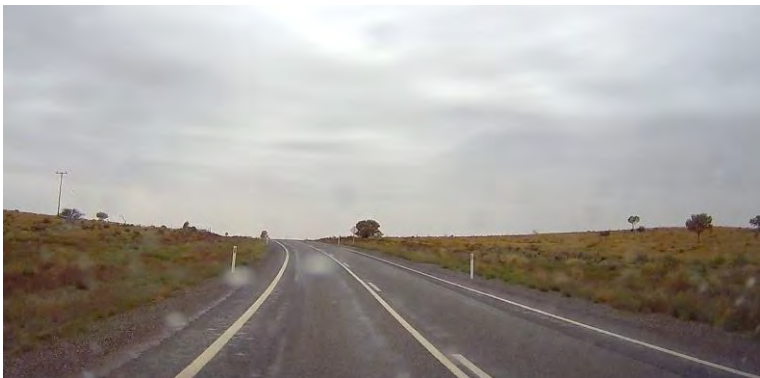
The next example highlights a moderately curved section of Silverton Road with no significant fixed hazards on the roadside. This example section is rated three stars, mostly owing to the 90km/h speed limit. At 100km/h or 110km/h the star rating would likely be two stars, or a very low three stars due to the absence of roadside hazards.

★★★★★☆ (8.12)	<p><u>Positives</u></p> <ul style="list-style-type: none"> <li>• No significant roadside hazards</li> <li>• Medium lane width</li> <li>• Medium sealed shoulder width</li> <li>• Low traffic volume</li> <li>• No intersections/property access points</li> </ul> <p><u>Negatives</u></p> <ul style="list-style-type: none"> <li>• Poor pavement condition</li> <li>• Moderate curvature</li> <li>• 90km/h speed limit</li> </ul>
